Environmental Opinion Letter – 9 Erskine Lane – View Royal BC

Attachment I – Overview Map of the Property

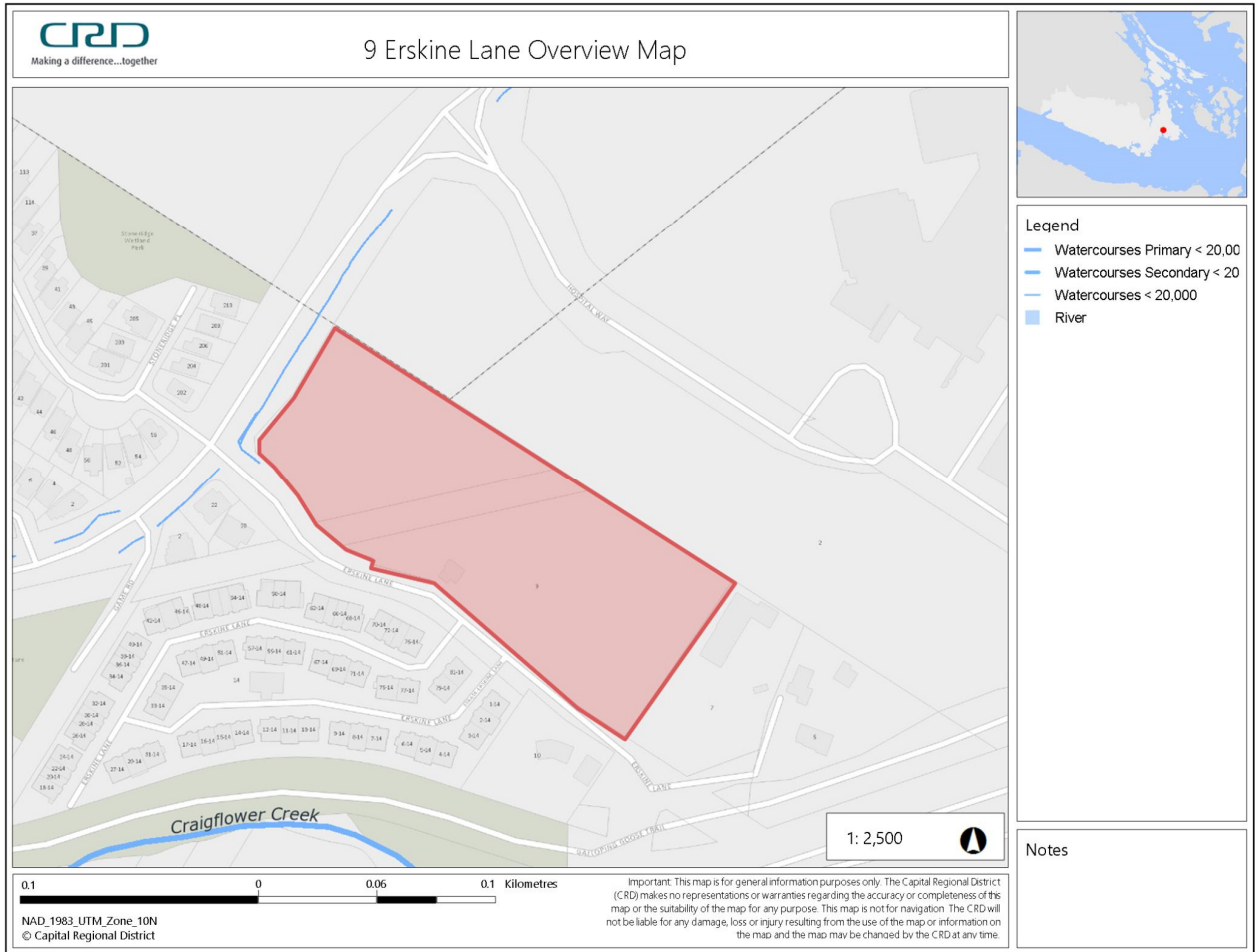
Attachment II – Overview Map of the Property with Ditches Presented as Blue Polylines (west and southwestern flank)

- 1) There are no watercourses found within the subject property that meet the definition of a watercourse under the RAPR legislation;
- 2) There are no watercourses meeting the RAPR legislation within 30m of the subject property that would project a 30m Riparian Assessment Area (RAA) onto the property;
- 3) The ditches assessed on site and presented in Attachment II (solid blue polyline) are non fish bearing;
- 4) The ditches assessed on site and presented in Attachment II (solid blue polyline) do not meet the definition of a watercourse under the RAPR as a result of the

absence of overland flow connectivity, the absence of mineral alluvium as well as the absence of any signs of scour. The ditches do not meet the RAPR criteria for fish habitat.

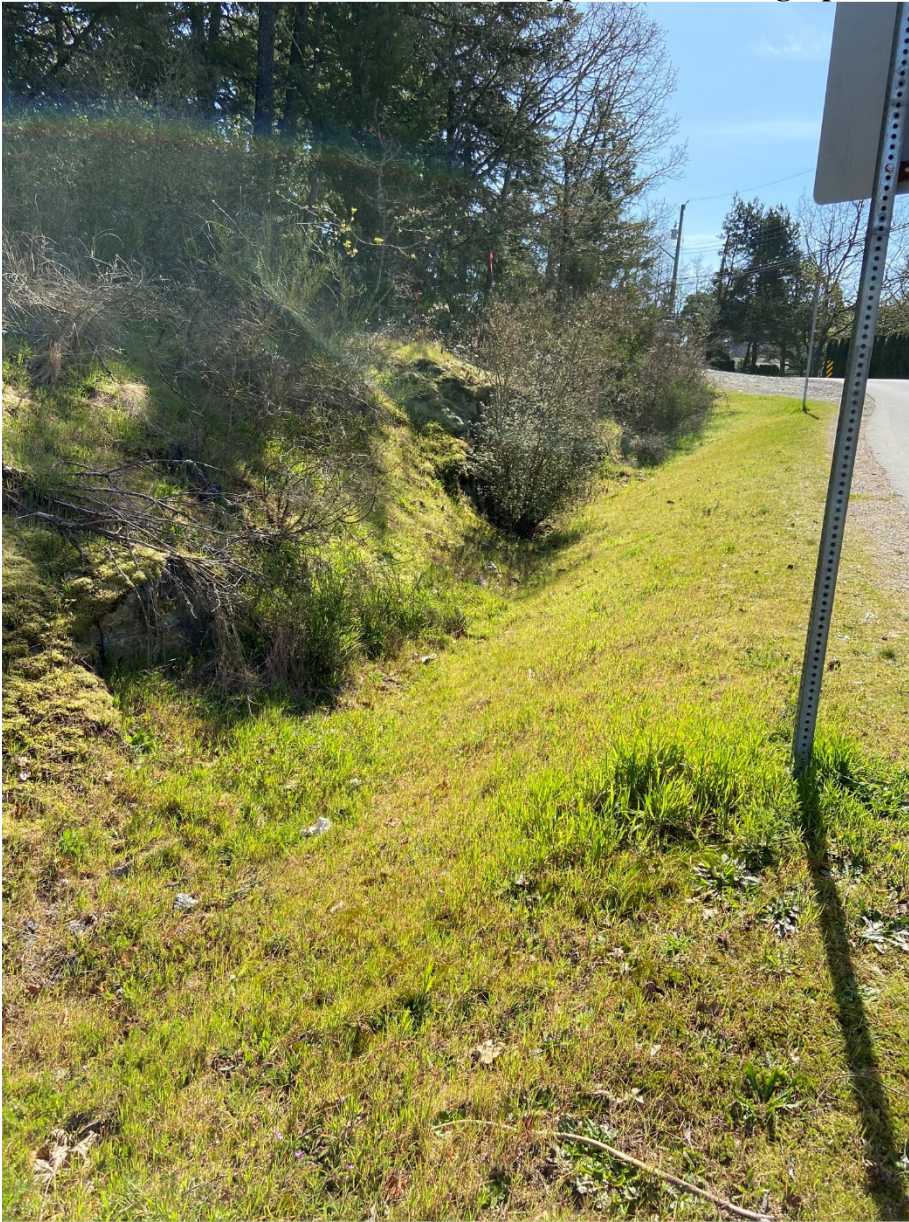
Plate #1 – Typical view of the existing wetted depression/ditch onsite along the southwestern corner of the property

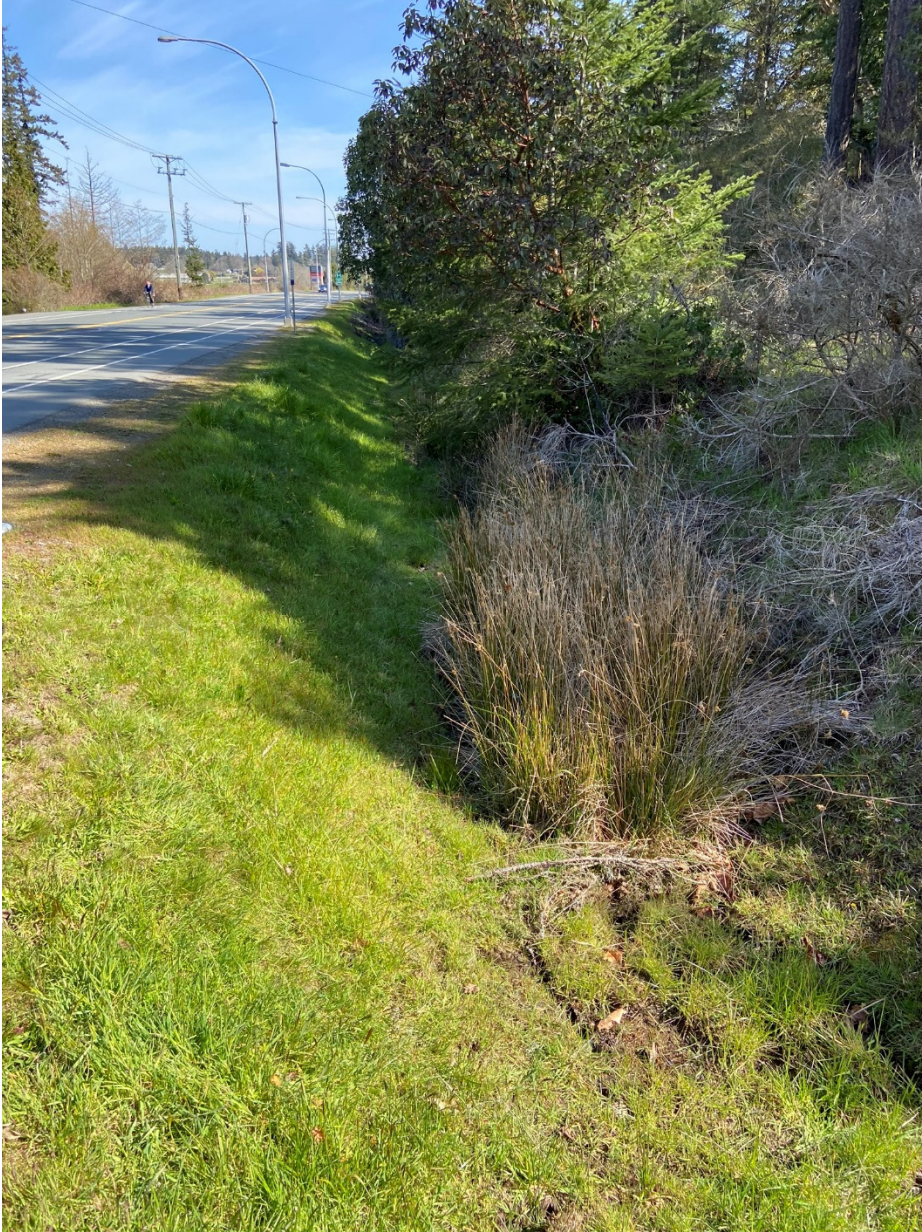
Plate #2 – Typical view of the existing wetted depression/ditch onsite along the western flank of the property
