# Phase I Environmental Site Assessment

9 Erskine Lane,  
View Royal, British Columbia

July 25, 2019

Pinchin File: 243564.000

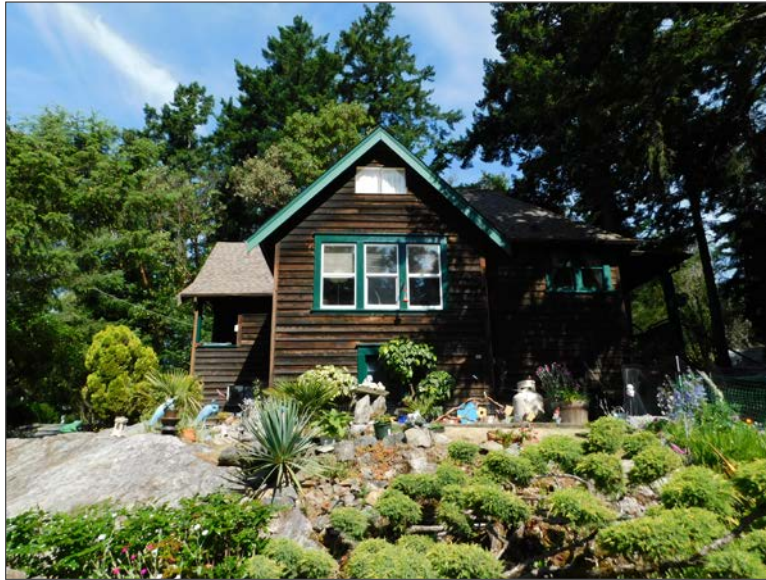
Photo 1 – View of the south elevation of Site Building A.

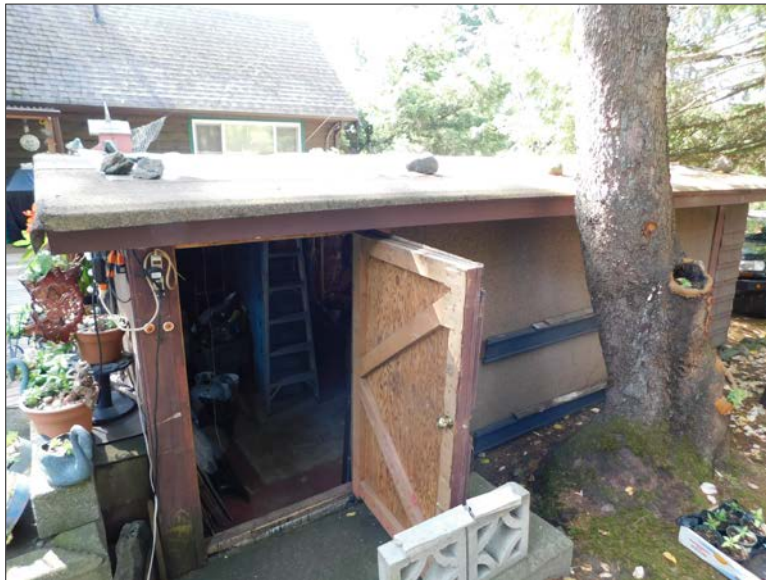
Photo 2 – West elevation of Site Building B.

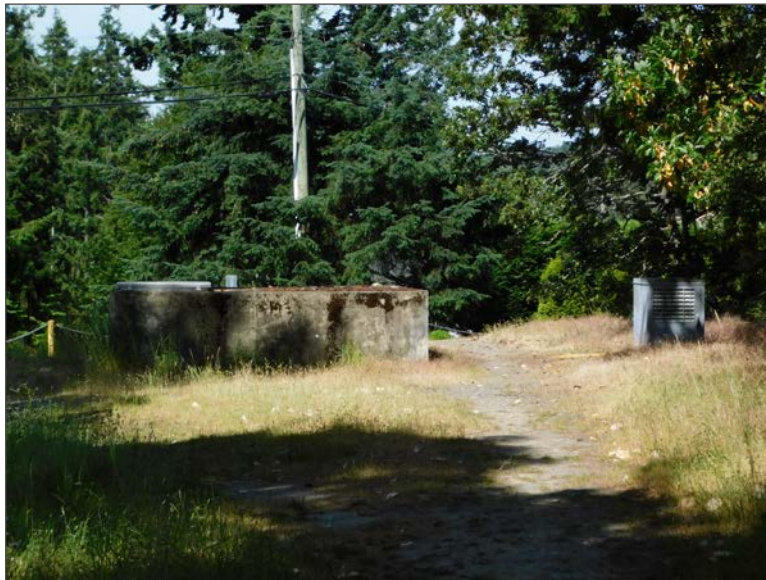
Photo 4 – Municipal water line and associated infrastructure constructed through the Site, as well as the northern portion of the Site.

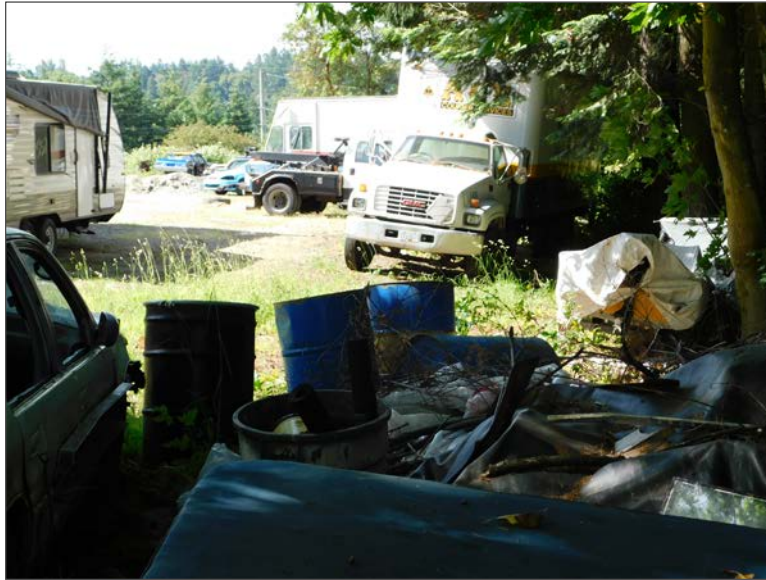
Photo 7 – Properties located east of the Site.

Pinchin notes that the main on-property building, located approximately 10 m east of the Site, contains a repair shop, fabrication bay and storage bay. The landfilling was identified throughout the property and adjacent to the east of the southern portion of the Site. The landfilling was also identified to be encroaching onto the Site by approximately 5 to 6 m.
