Re: Rezoning Application for 9 Erskine Lane

ERSKINE MULTIFAMILY

9 ERSKINE LANE, VIEW ROYAL, BC

ISSUED FOR REZONING

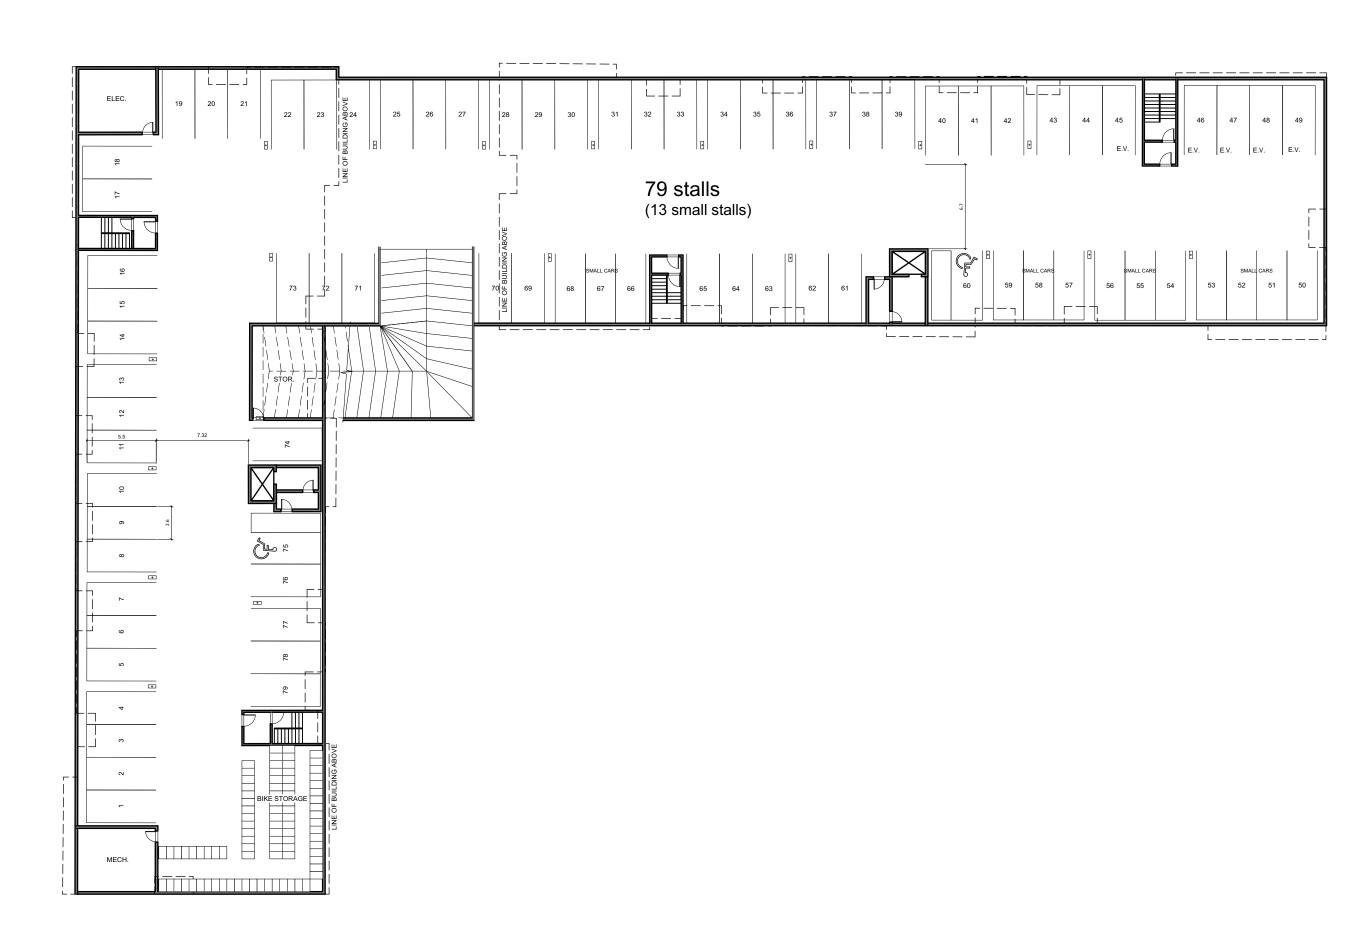
PARKADE LOT A - P1 LEVEL

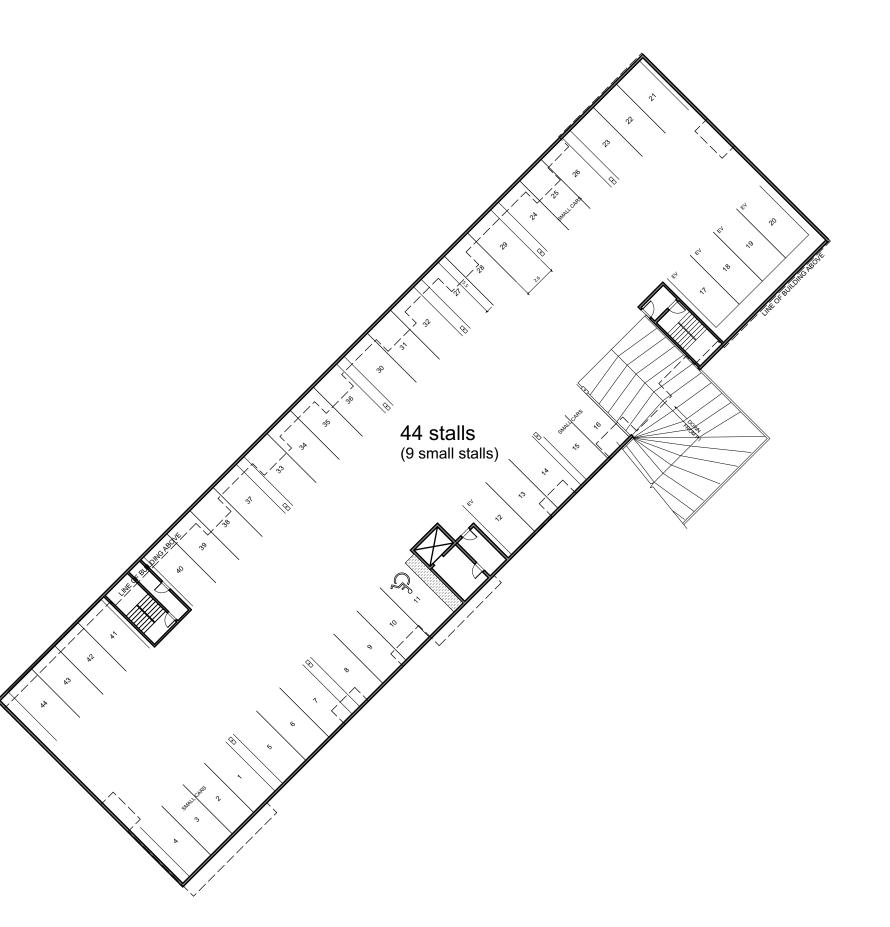
PARKADE LOT A - P2 LEVEL

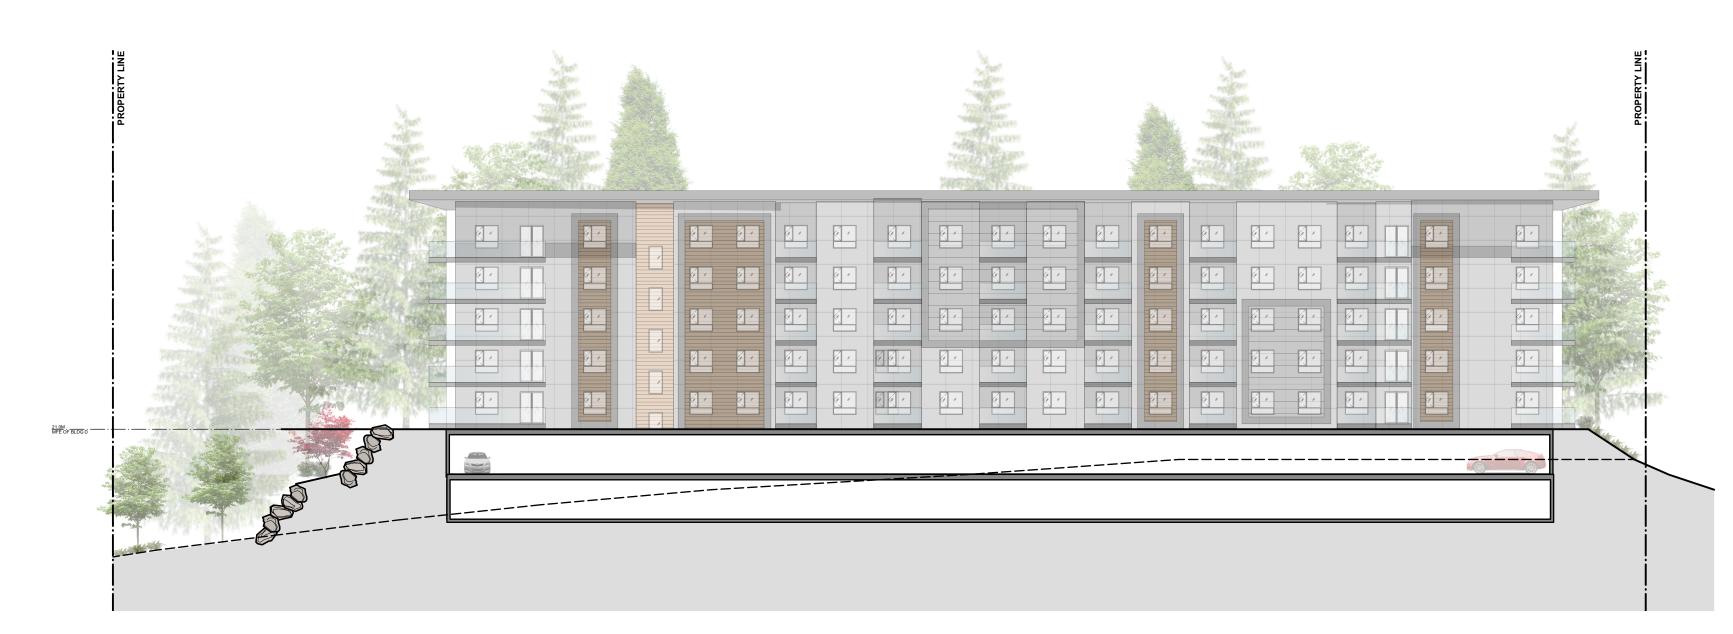
F SITE SECTION F 1:250

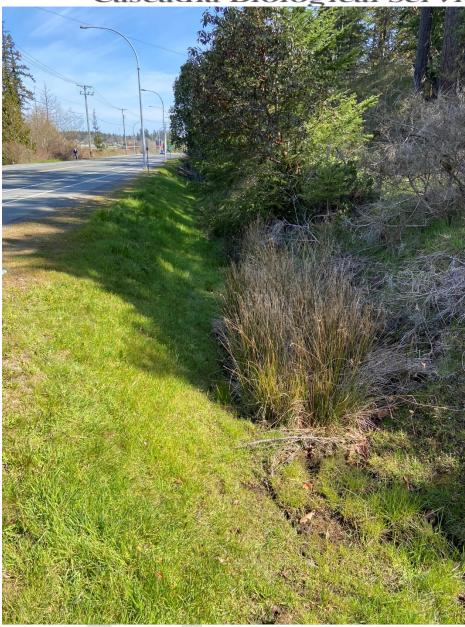
Plate #2 – Typical view of the existing wetted depression/ditch onsite along the western flank of the property

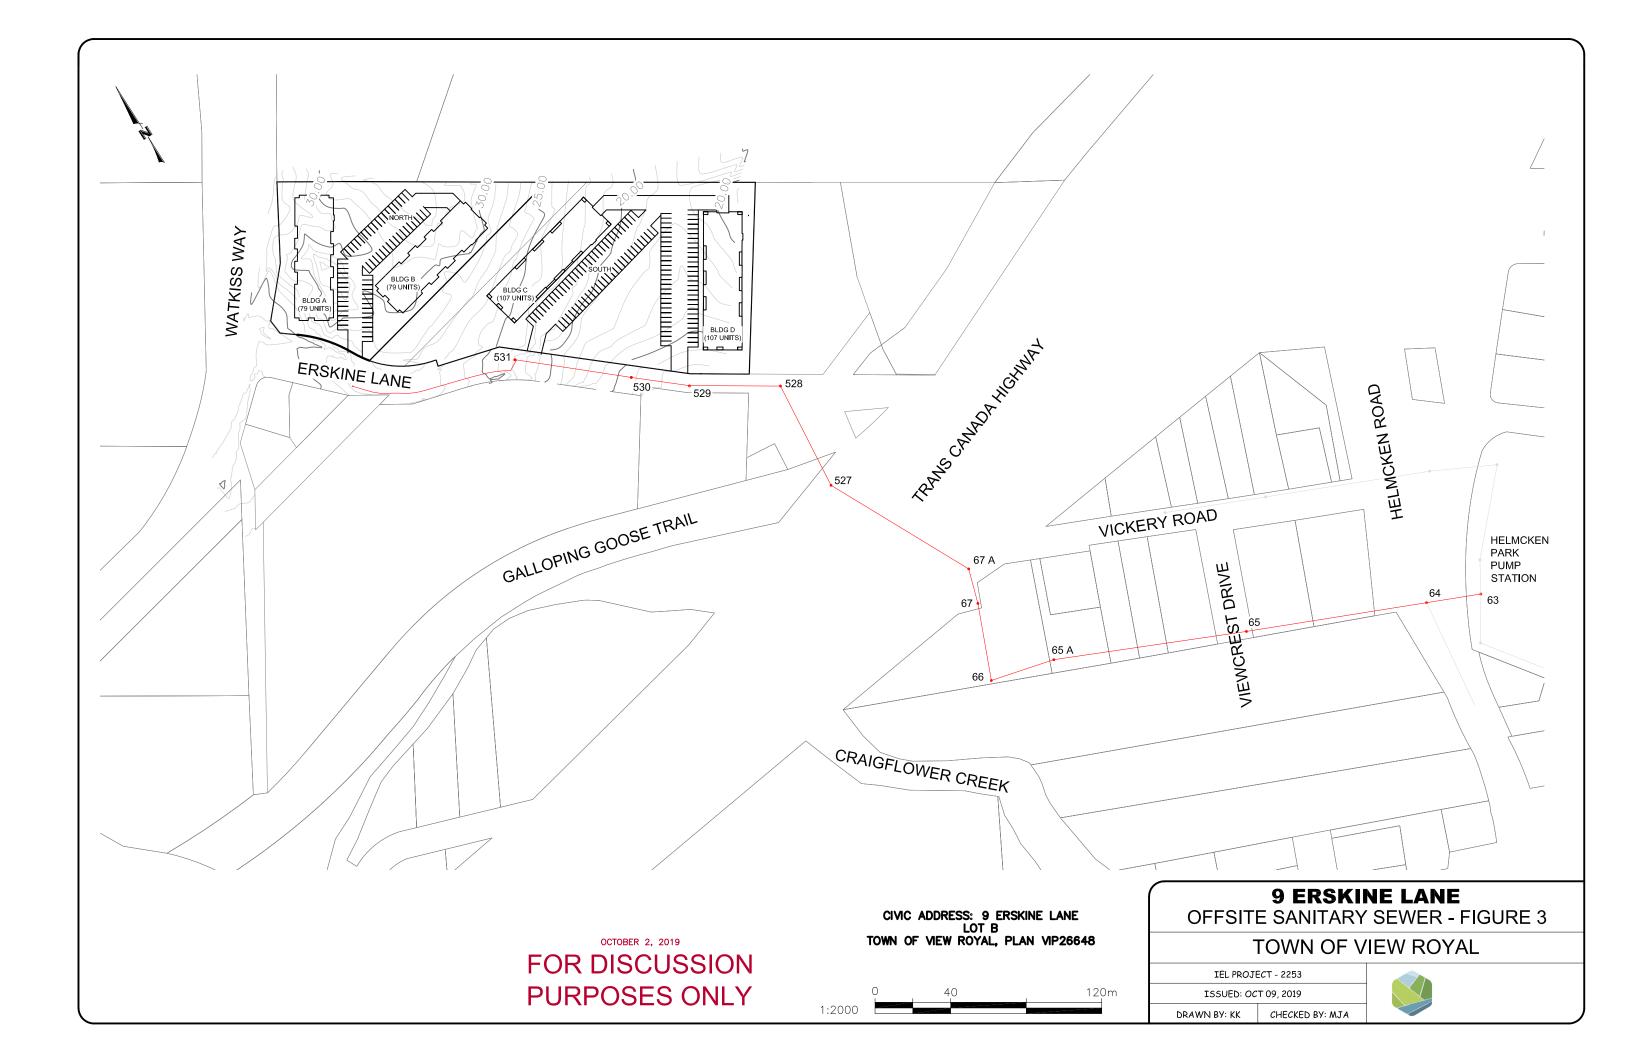
APPENDIX C OFFSITE SANITARY SEWER - FIGURE 3 AND SANITARY SEWER CAPACITY ASSESSMENT

The existing sanitary system capacity has been reviewed from the development site down to the CRD Craigflower Pump Station and the output of this analysis has been included in Appendix C. The system was modeled under constant peak flow conditions for 24 hours and found to be operating at 54% capacity. The results of this analysis are summarized in Table 3 below:

Post development flow modeling is also included in Appendix C. The system was modeled under constant peak flow conditions for 24 hours and found to be operating at 45% capacity. The results of this modeling exercise are included in Table 4 below:

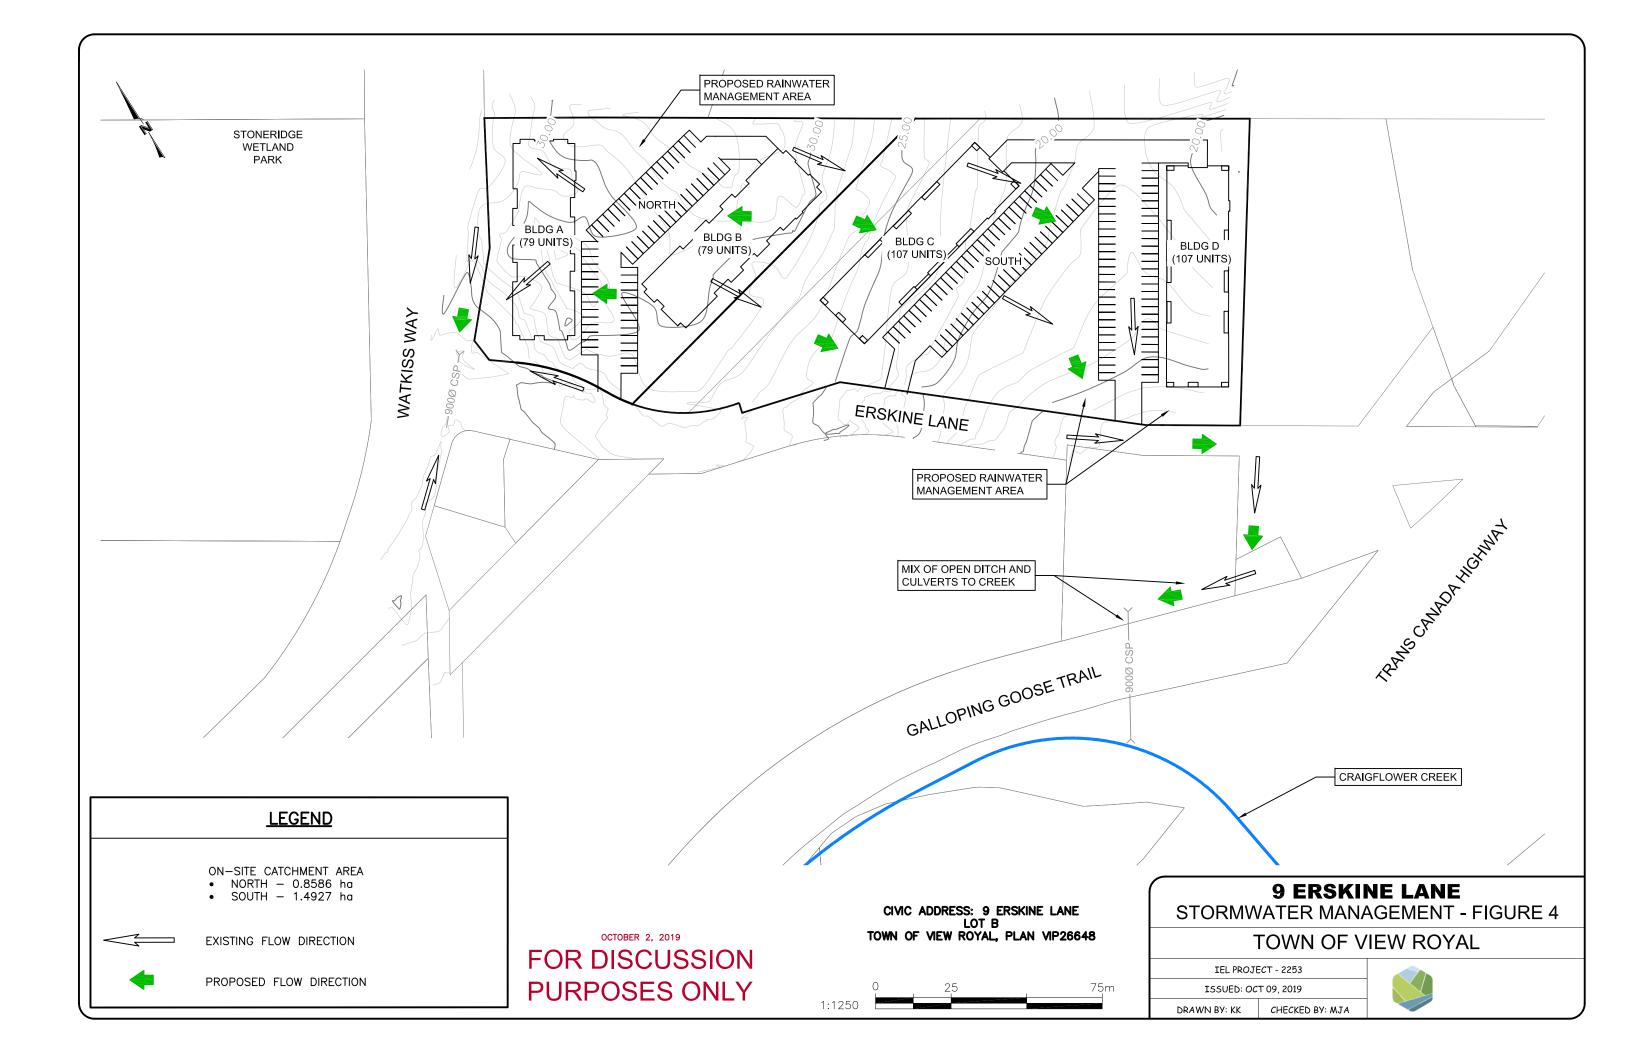
APPENDIX D STORMWATER MANAGEMENT - FIGURE 4

The proposed storm water management system will employ a treatment train including strategically located rain-gardens and absorbent landscaping BMPs. Runoff from paved surfaces and roof leaders, where possible, will be collected within biofiltration raingardens. Post-development storm water management onsite is expected to reduce the discharge to the municipal system when compared to the existing pre-development conditions due to detention and controlled release measures. Tables 7 and 8 summarize the existing and proposed storm water discharge conditions from the site:

Following the construction of detention and controlled release systems for storm water discharge from impervious surfaces, the overall peak discharge rate from the site will be lower than the pre-development conditions, therefore no upgrades to the downstream storm water infrastructure are expected to be required. The onsite detention facilities will attenuate the peak flow below pre-development conditions, negating the need for downstream upgrades.

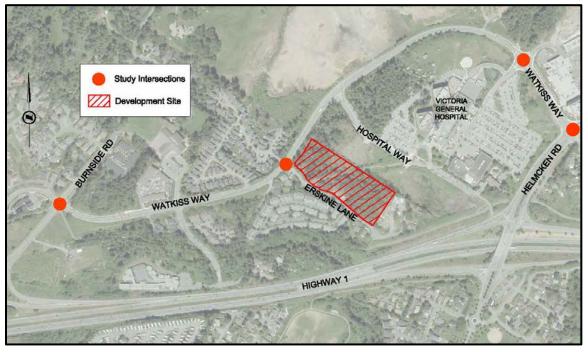
Figure 1: Study Intersections and Site Location

Figure 1 shows the study intersections and site location.

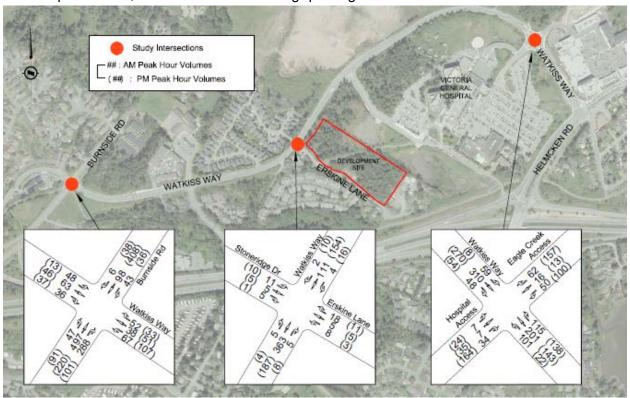
Figure 2: 2019/2020 Existing Traffic Volumes

The existing 2019 / 2020 AM and PM peak hour conditions are summarized in **Table 1**, and traffic volumes are shown in **Figure 2**. All intersections operate at LOS C or better in the AM and PM peak hours, and there are no existing queuing issues.

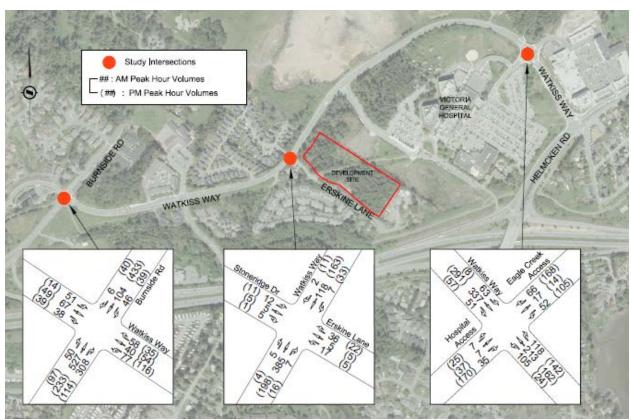
Figure 5: 2022 Background Traffic Volumes

The 2022 AM and PM peak hour conditions are summarized in **Table 3**, and traffic volumes are shown in **Figure 6**. All intersections operate at LOS C or better in the AM and PM peak hours, and there are no queuing issues along Watkiss Way.

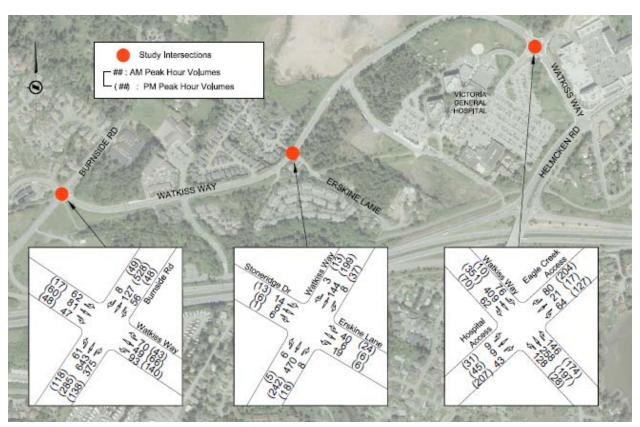
Figure 8: 2032 Background Traffic Volumes

The 2032 AM and PM peak hour conditions are summarized in **Table 5**, and traffic volumes are shown in **Figure 8**. All intersection movements along the Watkiss Corridor operate at LOS C or better in the AM and PM peak hours, except for the westbound movement at Burnside Road W / Watkiss Way which will operate at a LOS D based on existing signal timing and phasing. The eastbound queue at the roundabout will be 110m or approximately 15 vehicles; however, the movement operates at a LOS C.

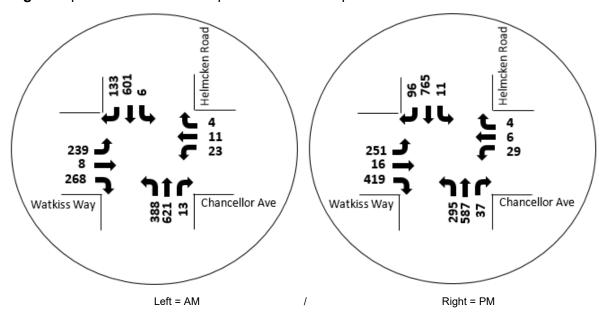
Figure 9: 2032 Background Helmcken Road/Watkiss Way Traffic

Figure 9 provides the 2032 AM peak hour and PM peak hour traffic volumes.

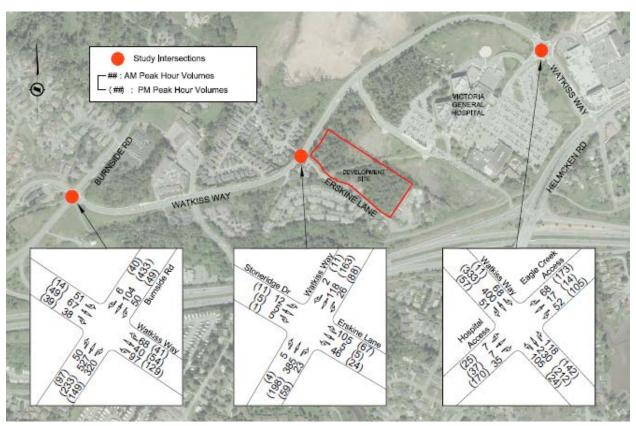
Figure 13: 2022 Post Development Volumes

The 2022 AM and PM peak hour conditions are summarized in **Table 9**, and traffic volumes are shown in **Figure 13**. All intersections along Watkiss Way operate at LOS D or better in the AM and PM peak hours, and there are no queuing issues. The westbound movement at Burnside Road W / Watkiss Way worsens to LOS D from LOS C with the addition of development traffic, however, only two additional seconds of delay are added indicating that the movement was already borderline at a LOS C/D.

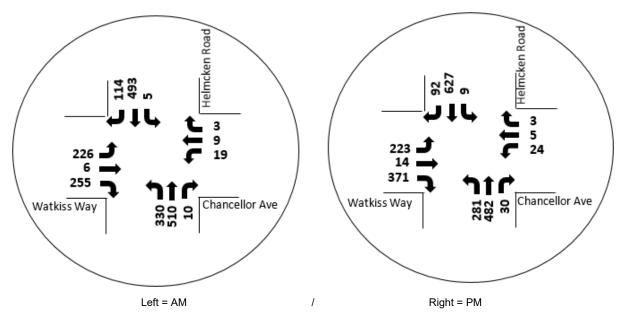
Figure 14: 2022 Post Development Helmcken Road/Watkiss Way Traffic

The following are the AM and PM peak hour post development traffic volumes at Helmcken Road / Watkiss Way.

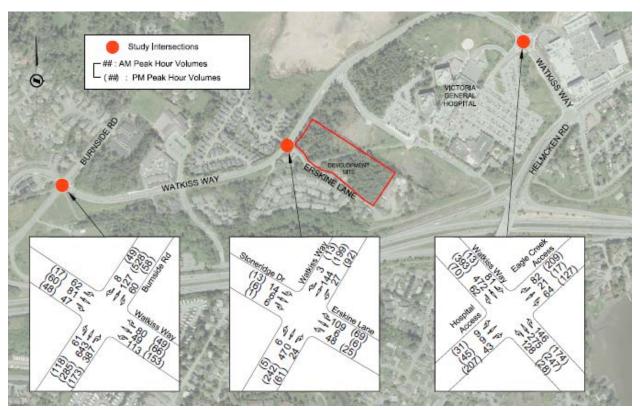
Figure 15: 2032 Post Development Volumes

The 2032 AM and PM peak hour conditions are summarized in **Table 11**, and traffic volumes are shown in **Figure 15**. All intersections the Watkiss Way Corridor operate at LOS D or better in the AM and PM peak hours. The addition of site traffic adds on a few seconds of delay to some movements; however, the level of service for most movements are unchanged compared to background conditions. The northbound/southbound movements on Erskine Lane/Stoneridge Drive at Watkiss Way will drop to a LOS D in the long term (from LOS C). The eastbound queue at the roundabout will increase to 170m (from 110m); however, it will operate at a LOS C. Therefore this queue will be 'rolling'.

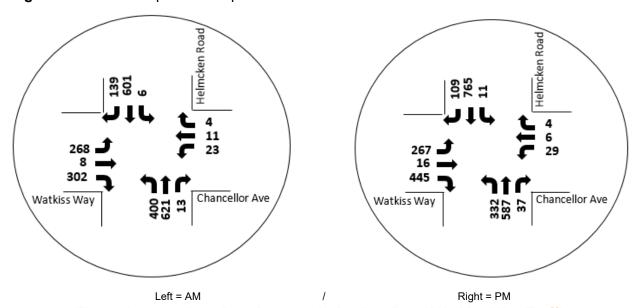
Figure 16: 2032 Post Development Helmcken Road/Watkiss Way Traffic

Figure 15 is the 2032 post development traffic volumes.

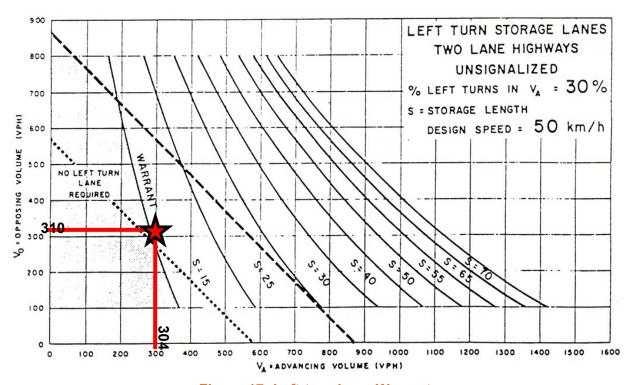
Figure 17: Left-turn Lane Warrant

A left-turn lane warrant was conducted in the PM peak hour at Erskine Lane / Watkiss Way for the westbound-left turn movement at the intersection. Although there is no reported operational issue, the number of vehicles turning left is significant (92 vehicles) and is approximately 30% of westbound traffic on Watkiss Way in the PM peak hour. The left-turn warrant indicates that a 15m left turn lane is required, though the warrant is barely met as shown in **Figure 17.** It is recommended that a left turn lane be added on Watkiss Way with the development.
