## TOWN OF VIEW ROYAL PUBLIC HEARING REPORT

### REZONING – 3, 5 and 9 Helmcken Road and 1449 Burnside Road West (Eagles Nest)

The purpose of this report is to support the Public Hearing for Bylaw No. 900, 2014 Amendment Bylaw No. 1050, 2020 to rezone the Burnside Helmcken properties at 3, 5 and 9 Helmcken Road and 1449 Burnside Road West (henceforward known as the ‘Eagles Nest’ property) to an attached 3-building apartment configuration with a proposed 247 units.

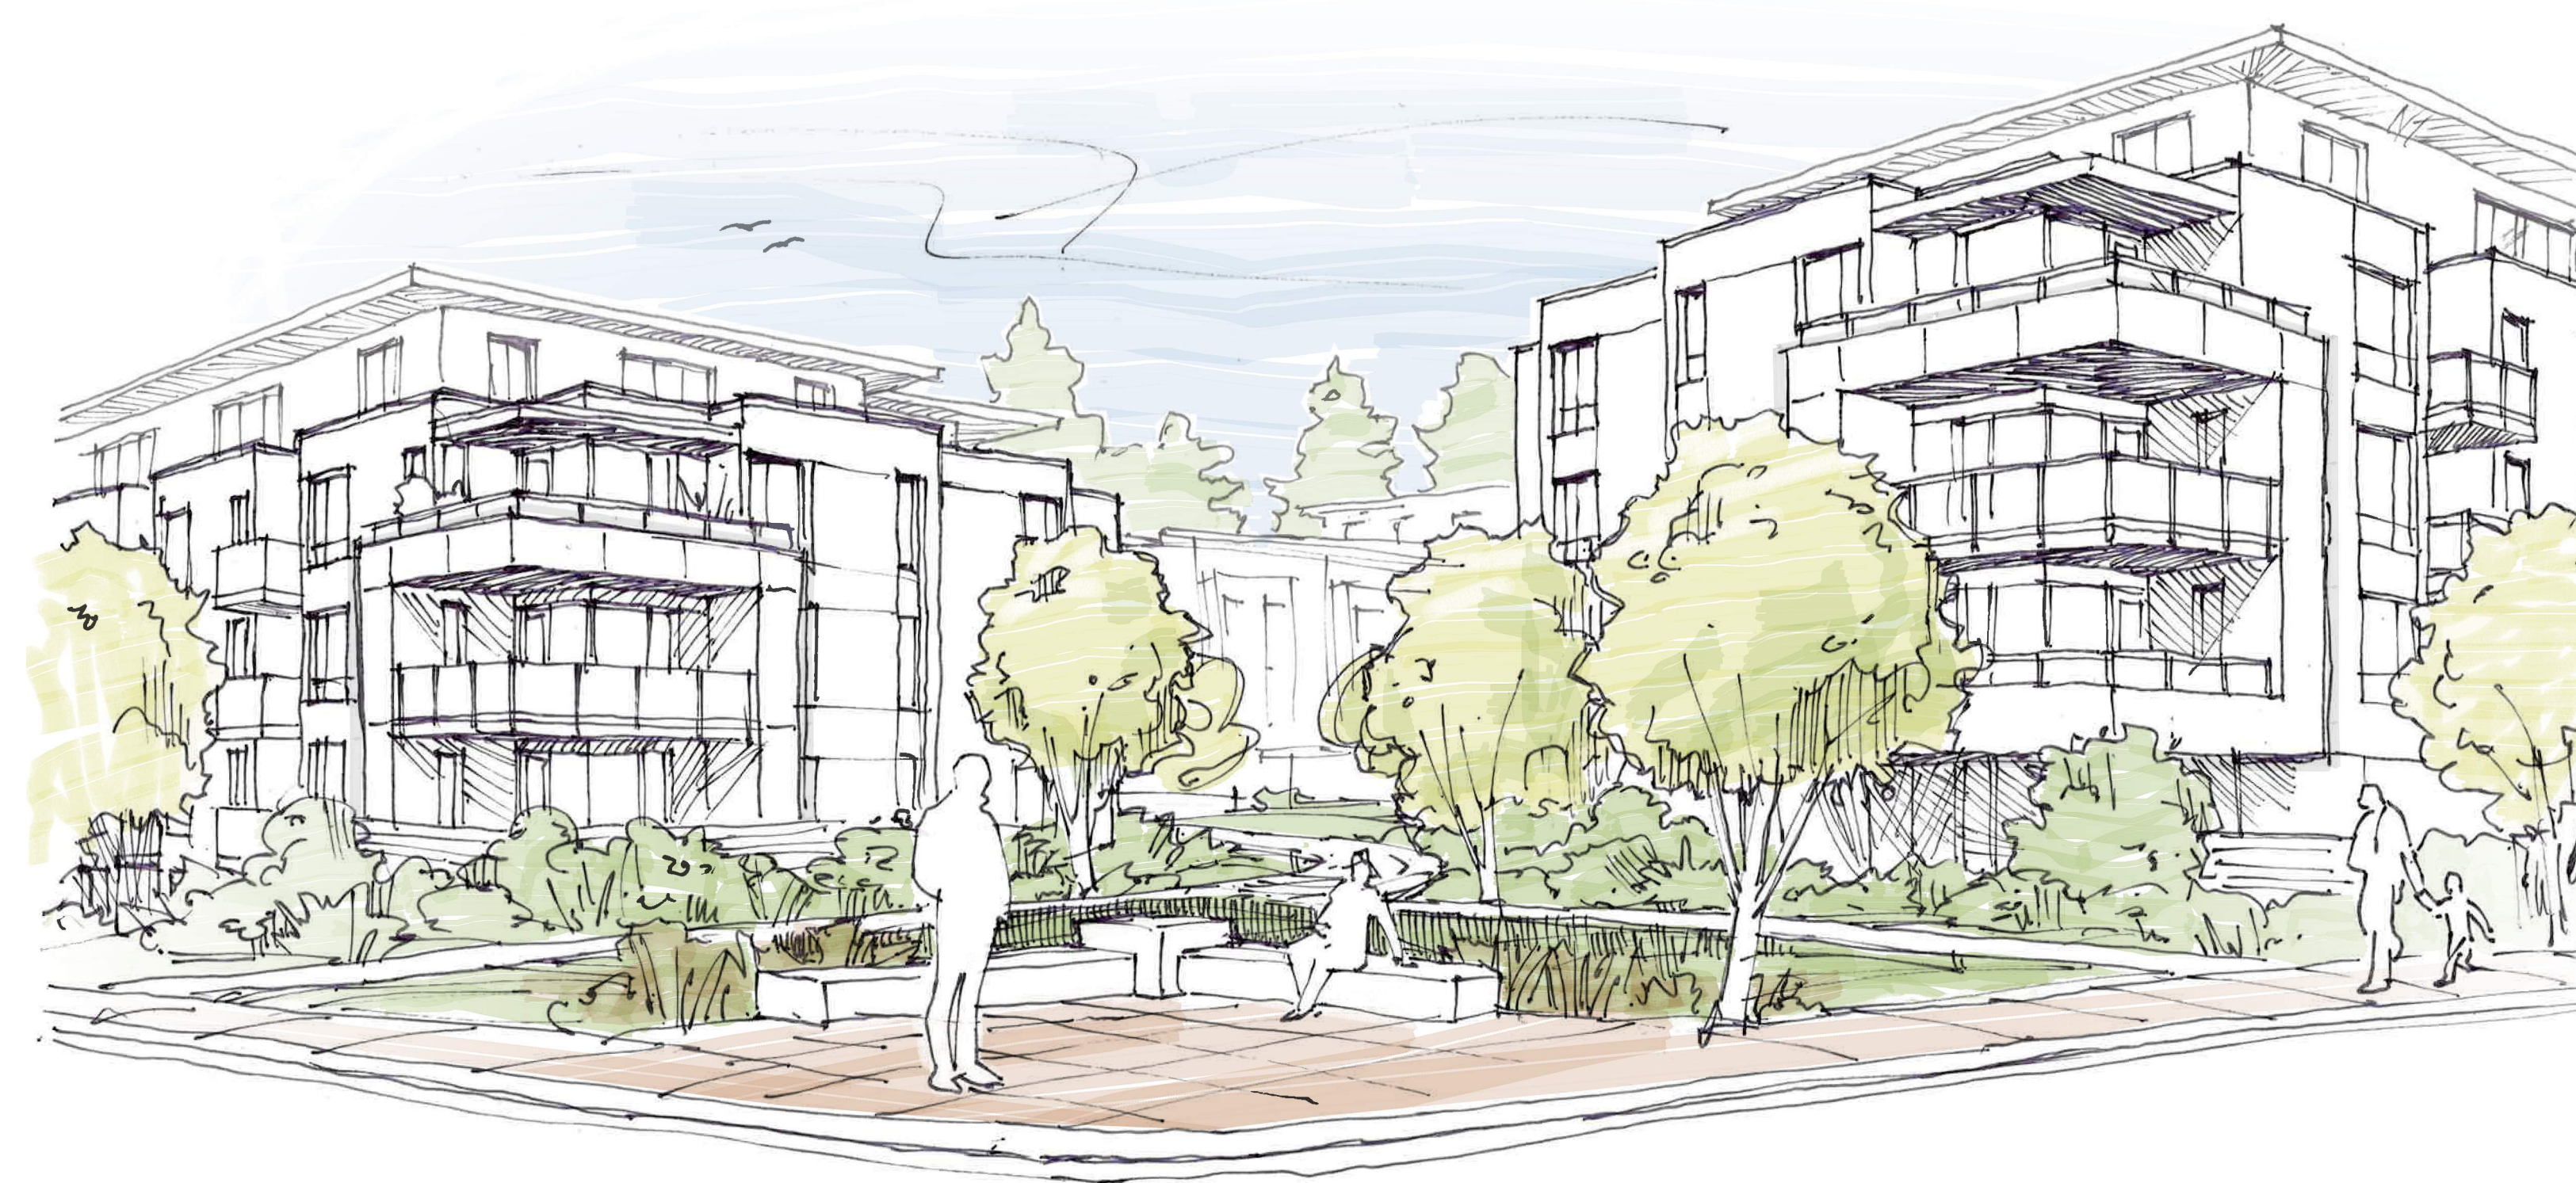
SECTION @ HELMCKEN

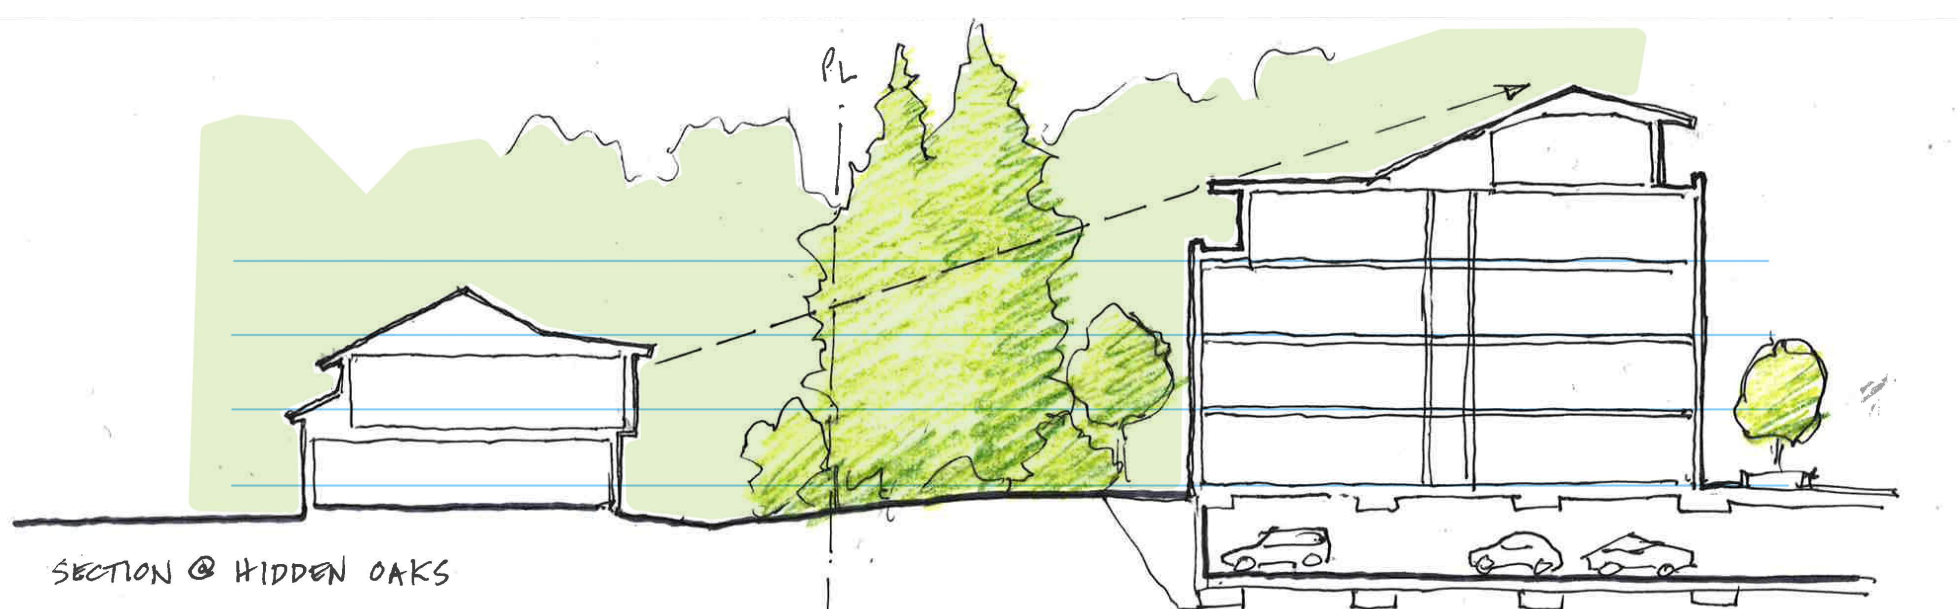
SECTION @ HIDDEN OAKS

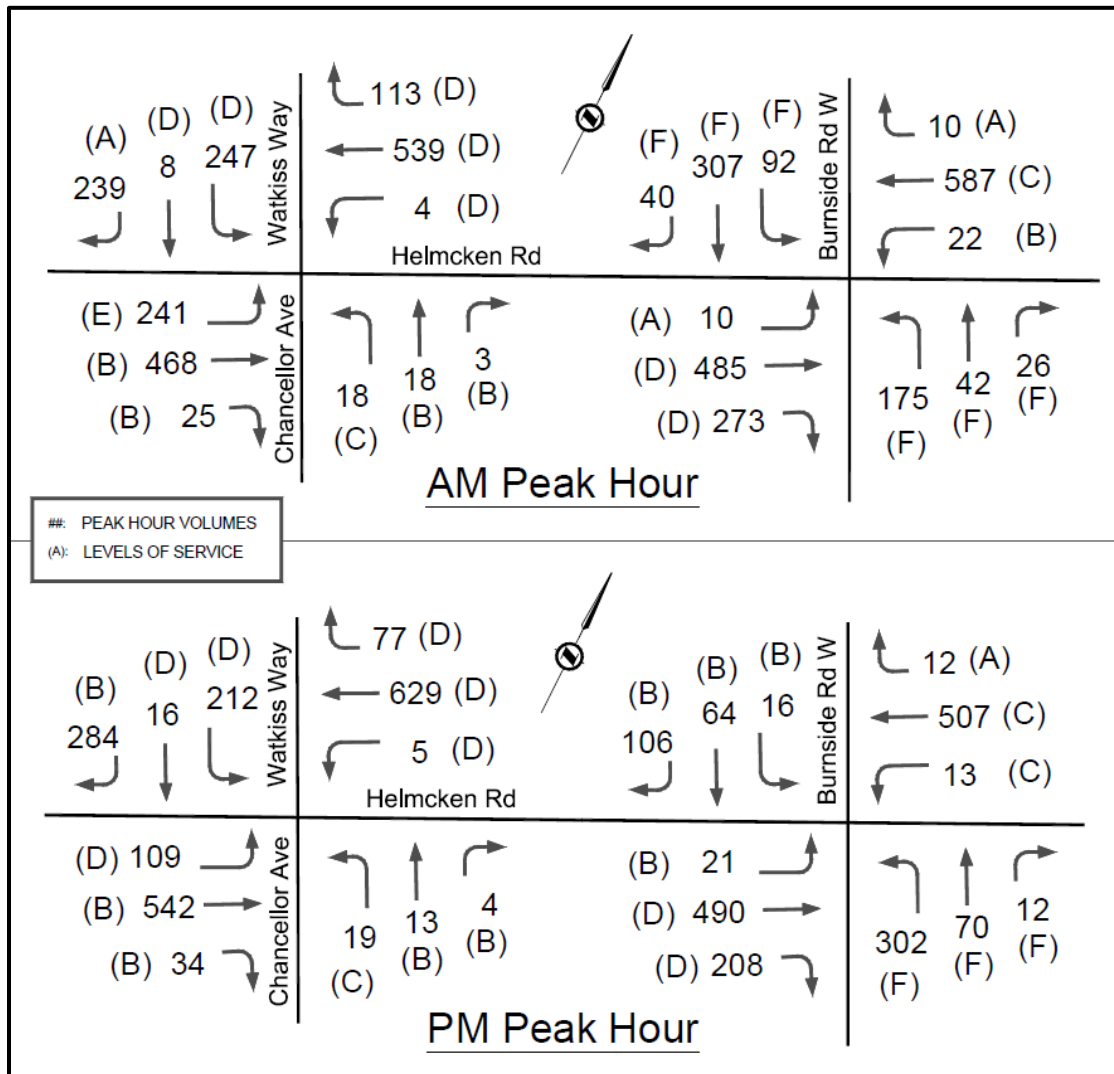
**Figure 2: 2018 Existing Volumes and Levels of Service**

limited storage on Helmcken Road for northbound left turning traffic from Burnside Road West. The Burnside Road West northbound left movement is further impacted by opposing southbound right turn traffic on Burnside Road West. However, there is potential for the current McKenzie Interchange project to improve conditions on Helmcken Road and Burnside Road West with the study area. Conditions at each intersection should be reassessed to confirm impacts on traffic when the McKenzie Interchange project is completed. See **Figure 2** for 2019 existing volumes and levels of service.

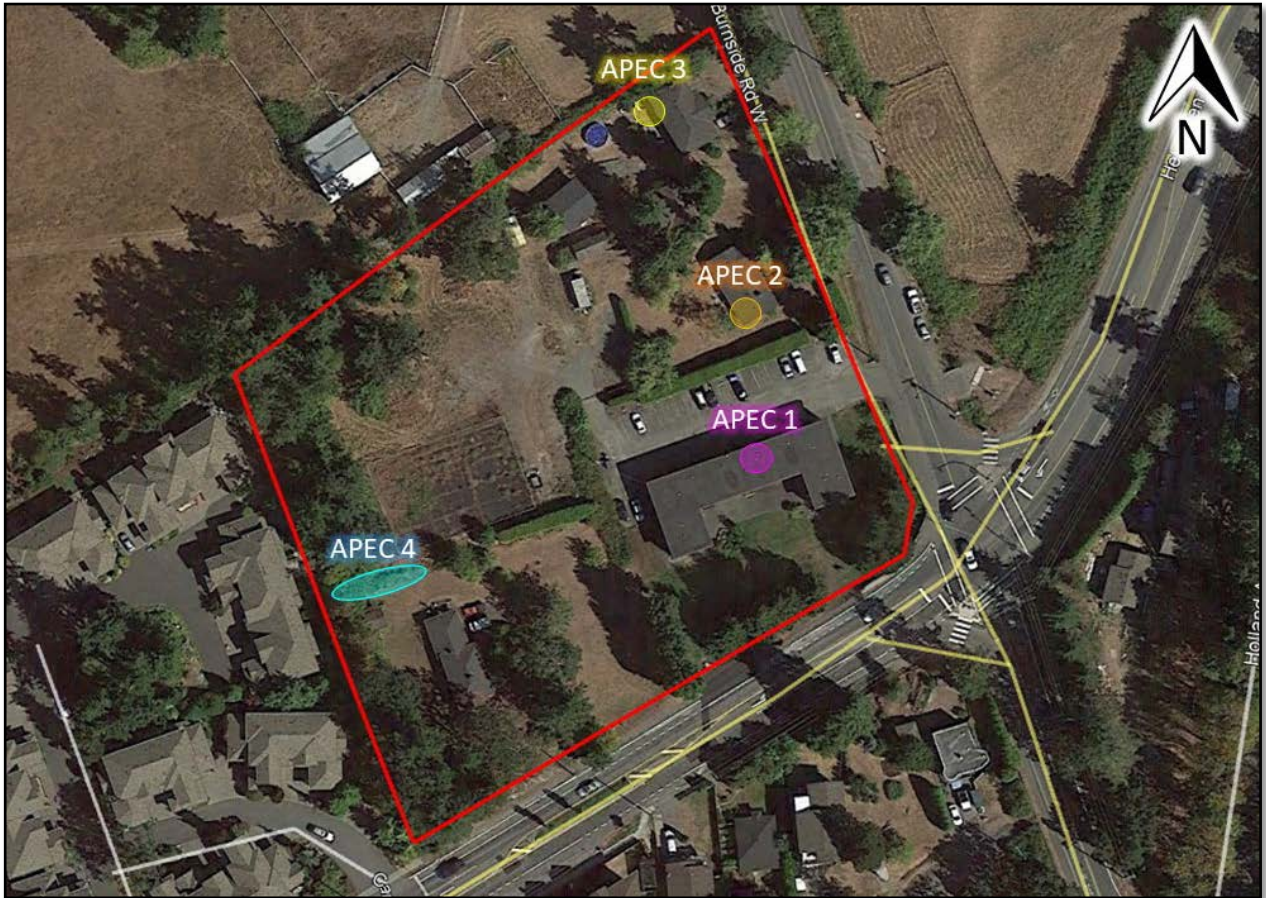
Figure. Areas of potential environmental concern.

Area of Potential Environmental Concern	Description
APEC 4	#5 Helmcken Rd poor housekeeping in the yard to the north of the house included disposal of a kerosene container, a 205 L steel drum of unknown contents and several other chemical containers inferred to be for lawn care and/or general home maintenance.

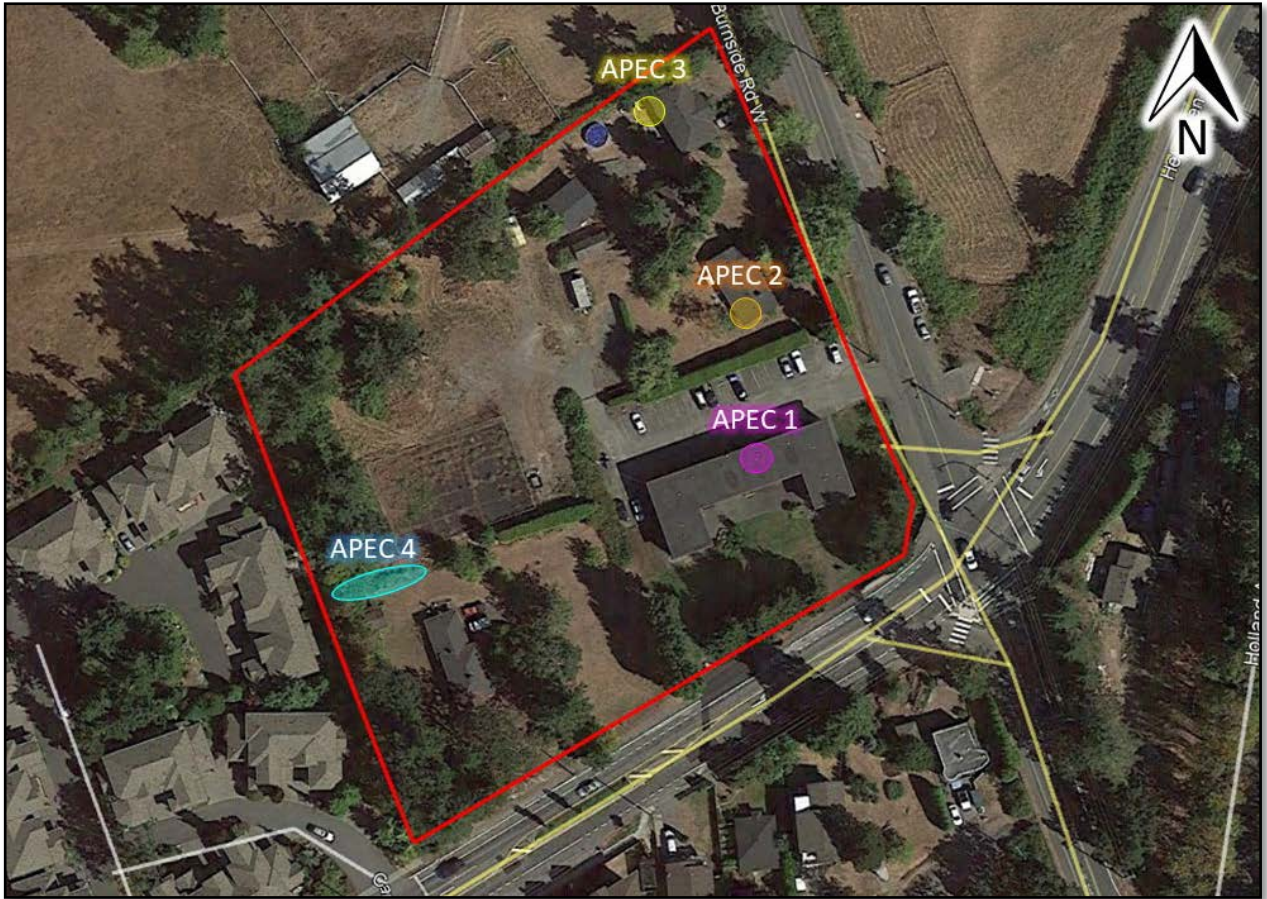
Figure 7. Areas of potential environmental concern.

Area of Potential Environmental Concern	Description
APEC 1	<b>3 Helmcken Rd</b> Approximately 1000 L heating oil tank. Small stains noted under the tank, gravel floor is directly adjacent to the AST providing a pathway for contamination to enter the subsurface.
APEC 2	<b>1445 Burnside Rd W</b> abandoned home heating oil AST in the crawlspace on the southwest corner of the building
APEC 3	<b>1449 Burnside Rd W</b> 1000 L heating oil tank located on the northwest corner of the building. The original tank was leaking as was replaced with the current tank.
APEC 4	<b>5 Helmcken Rd</b> poor housekeeping in the yard to the north of the house included disposal of a kerosene container, a 250 L steel drum of unknown contents and several other chemical containers inferred to be for lawn care or general home maintenance.

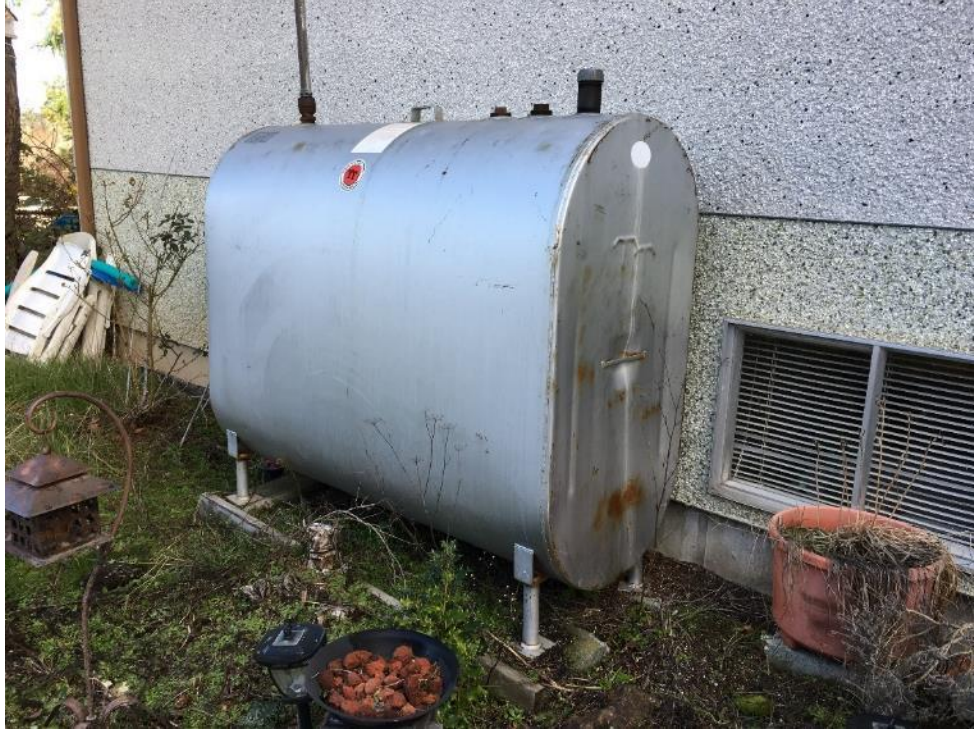
Photograph No.17: Heating oil AST on the west side of the house at 1449 Burnside Rd W

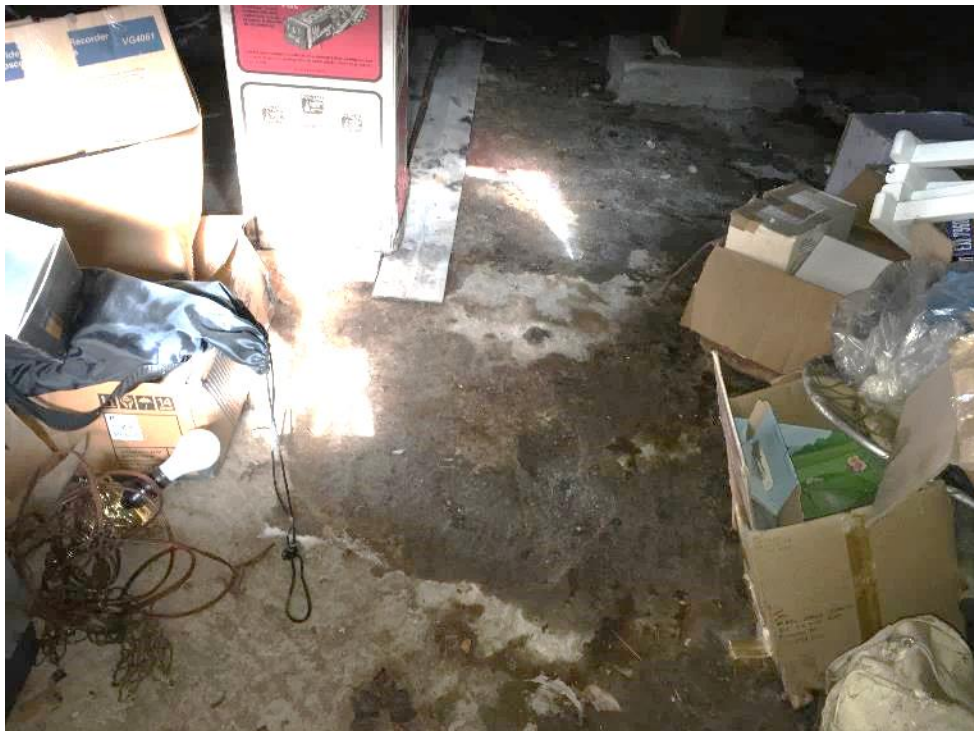
Photograph No.18: Staining on the floor of the crawl space under 1445 Burnside Rd W

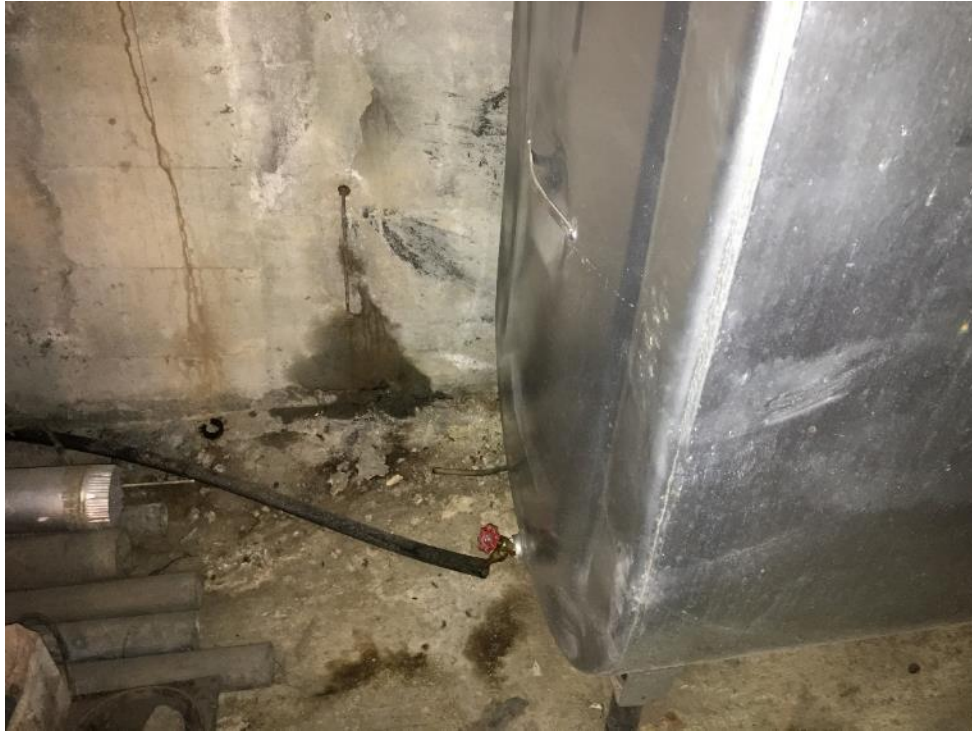
Photograph No.19: Staining under the valve of the AST at #3 Helmcken Rd

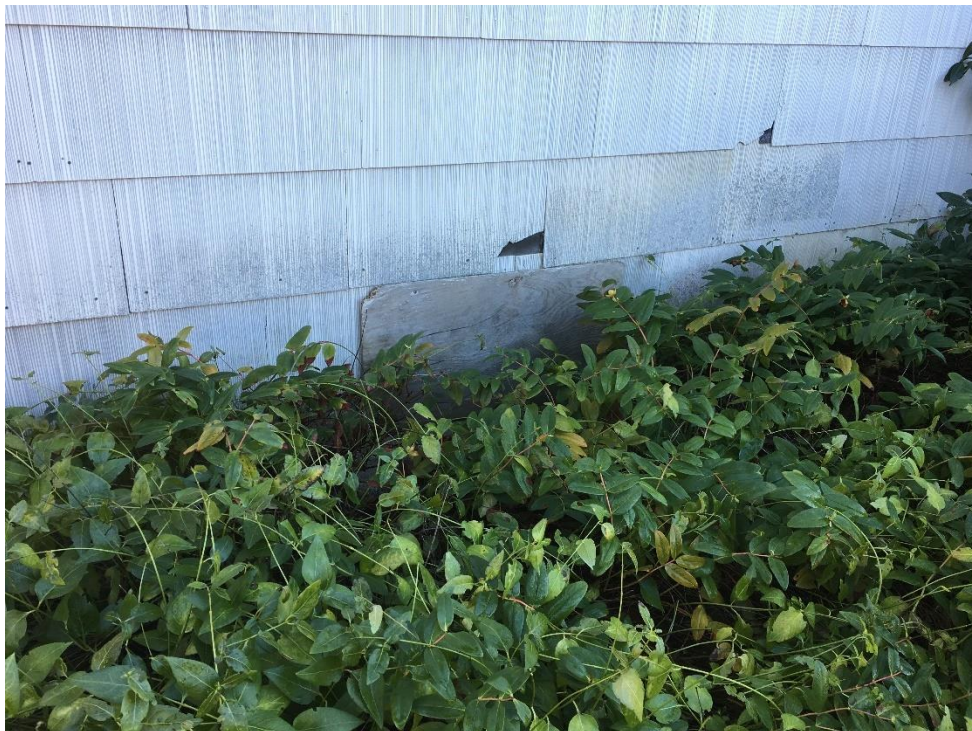
Photograph No.22: Asbestos cement siding on the house at 1447 Burnside Rd W

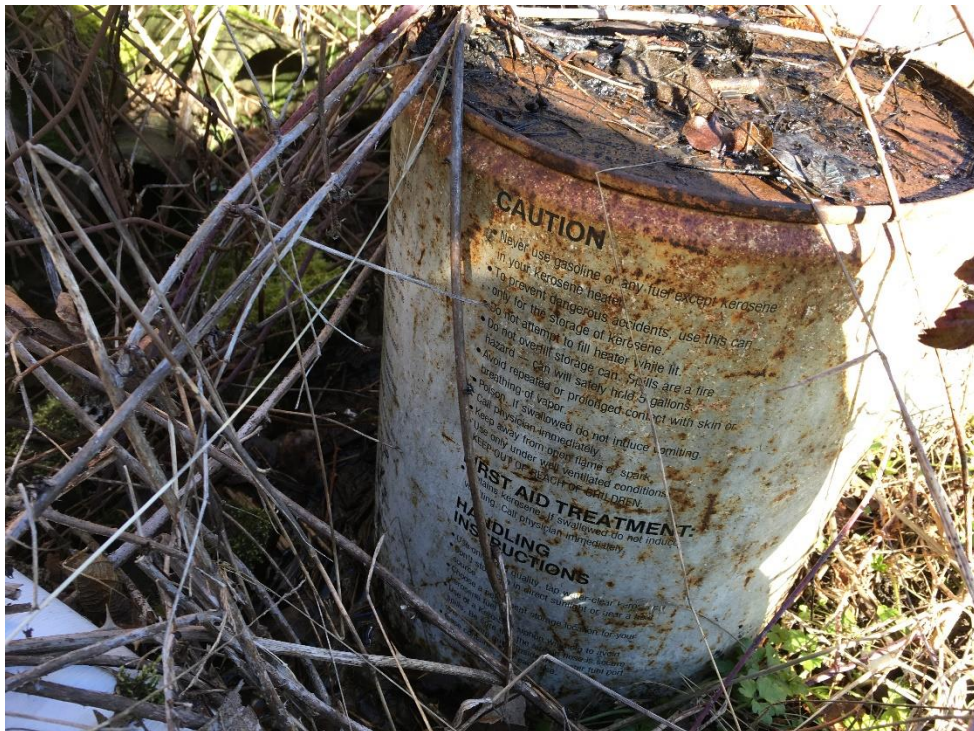
Photograph No.24: Rusted kerosene container in the scrap pile at #5 Helmcken Rd
