Six Mile Corridor Study

Six Mile Road Corridor Study
04-19-0077 October 2019

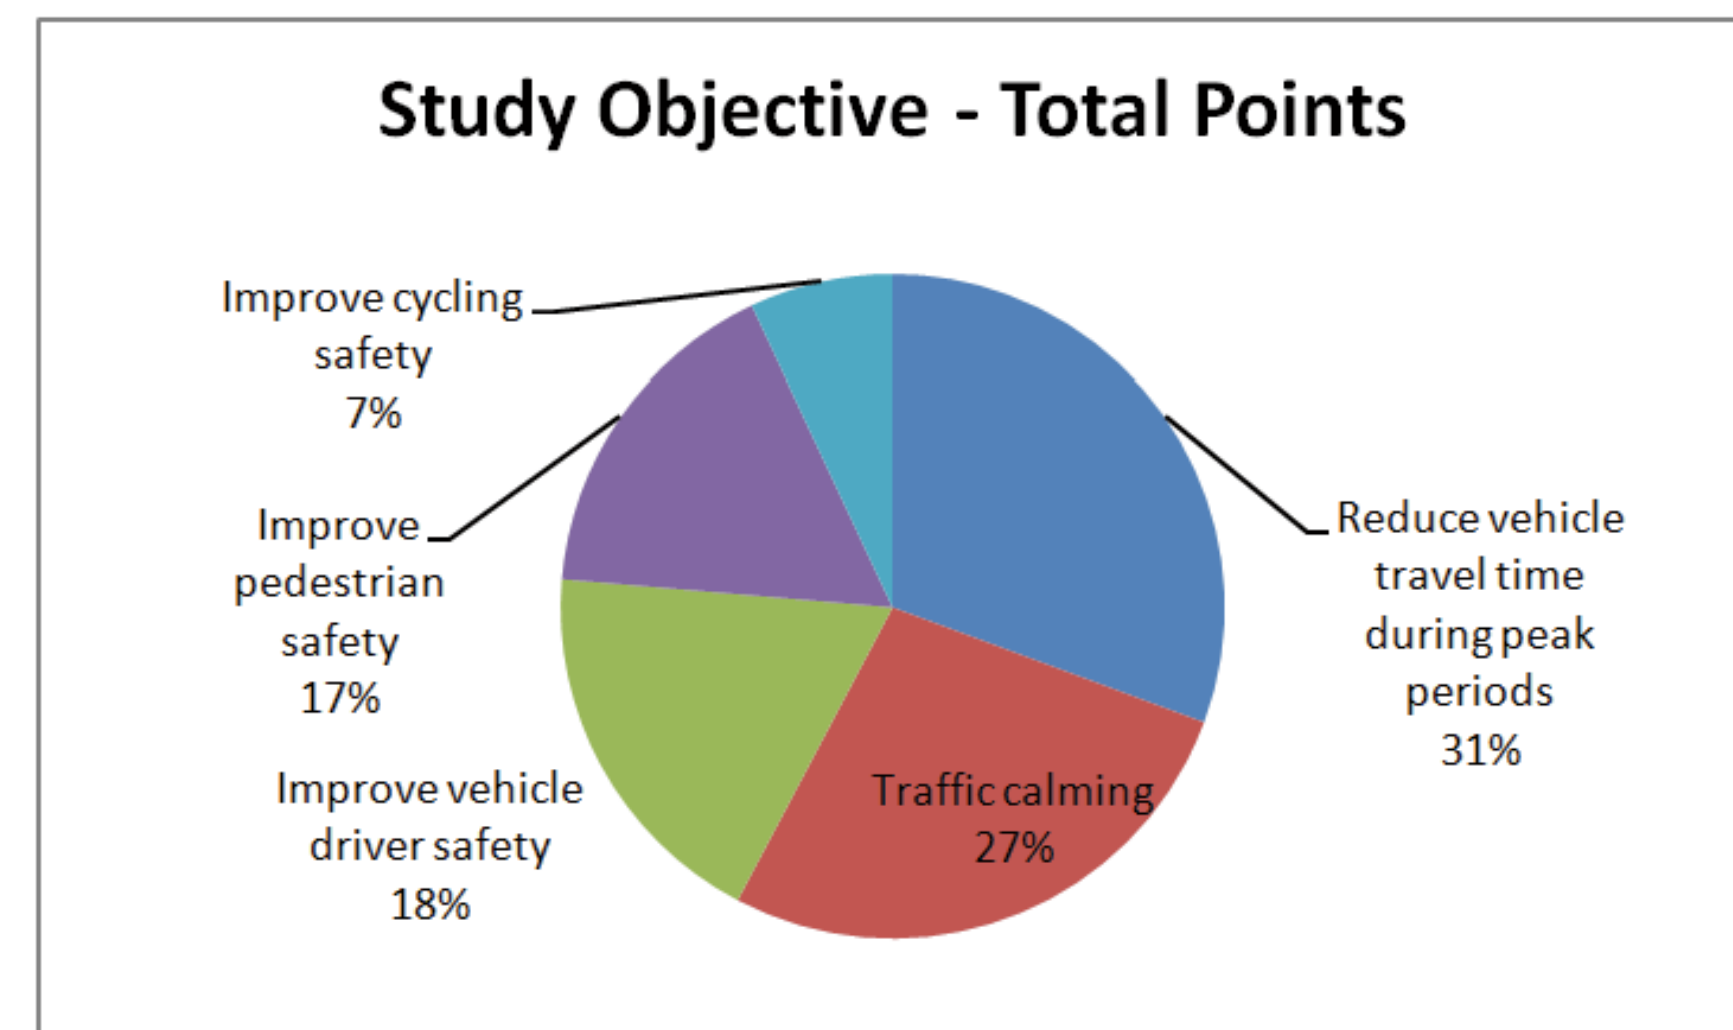
Figure 1: Objectives for Corridor - Total Points

47 Comment Sheets were filled in,. Results regarding primary corridor concerns are shown below.

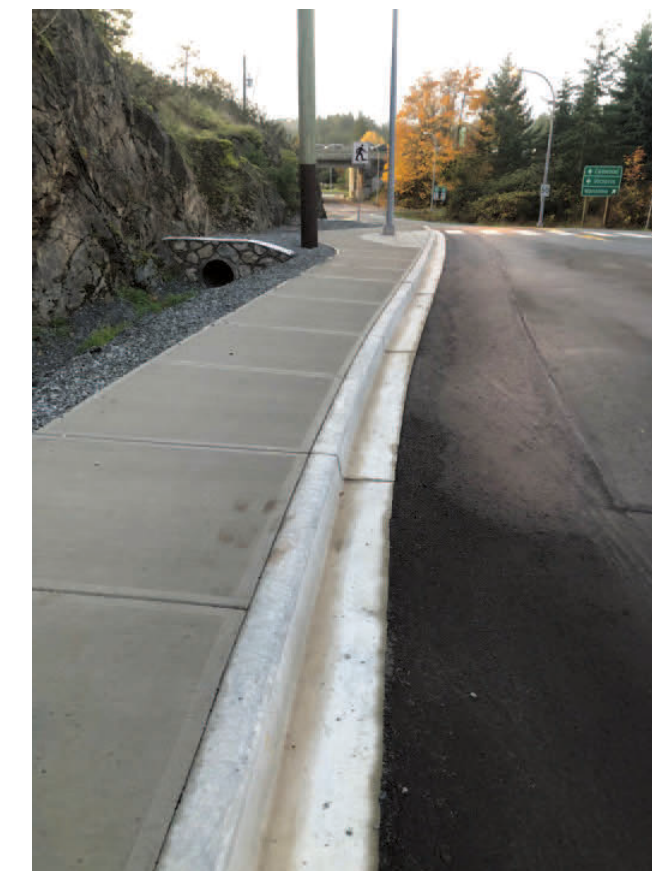
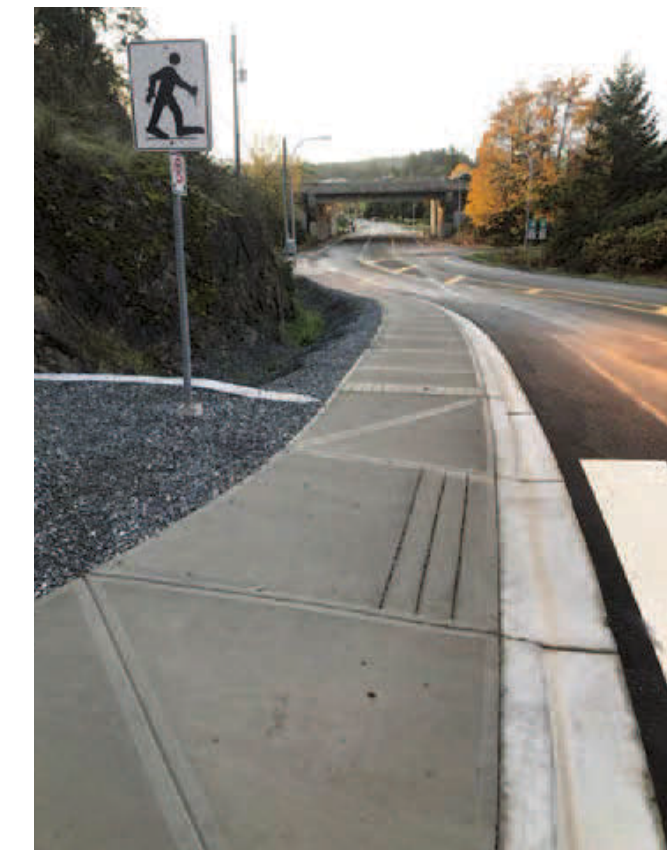
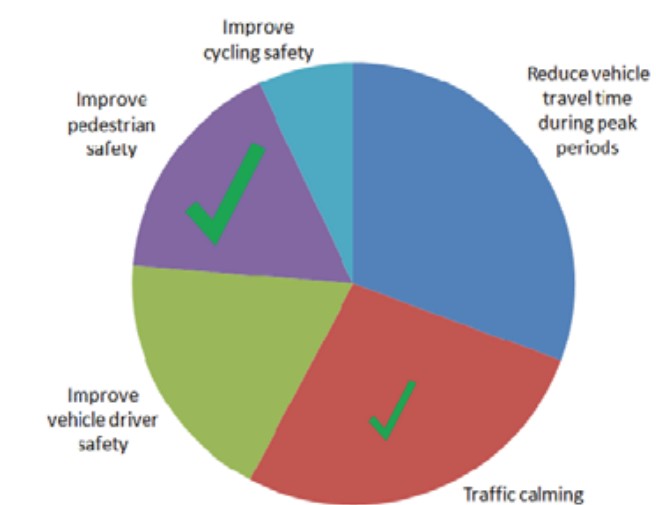
Photos: Facing South near West Park Lane

- Pedestrian safety, particularly during summer months when Thetis Lake parking lot overflow results in vehicles parking along Six Mile Road.
- No pedestrian link on Six Mile Road between Highway 1 Off-Ramp and Thetis Lake parking lot area.

Update: Sidewalk added to Six Mile Road's east edge in summer of 2019.

Improve pedestrian amenities along Six Mile Road's east edge.

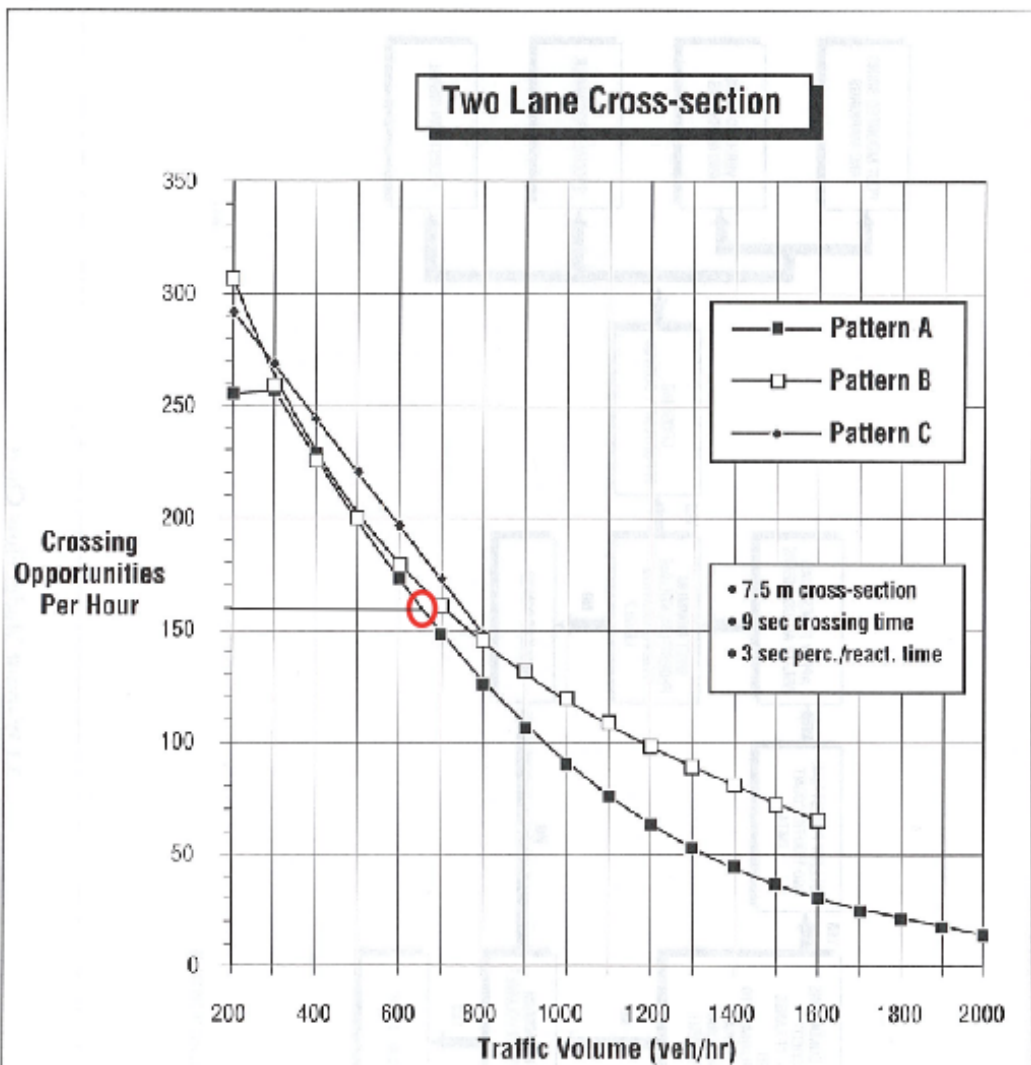
Figure 1: TAC Pedestrian Crossing Warrant

The existing pedestrian crossing has low pedestrian volumes during regular periods, however this increases during peak Thetis Lake periods. The two-lane profile of Six Mile Road with existing traffic volumes provides approximately 160 crossing opportunities per hour based on the future forecasted 2032 traffic volumes, as shown in **Figure 1**.

As shown in **Figure 2**, the crossing opportunity value of 160 crossing opportunities indicates that the crossing does not warrant a more robust crossing with push-button or overhead lights.

Chapter: Warrants	Unit: April 1994
Figure: 3.5A	Page: 3-13

- No recommended changes.
- Upgrading the pedestrian crossing to a Special Crosswalk is not anticipated to be warranted due to low volumes of pedestrians crossing at this location and the relatively low volume of vehicle traffic.

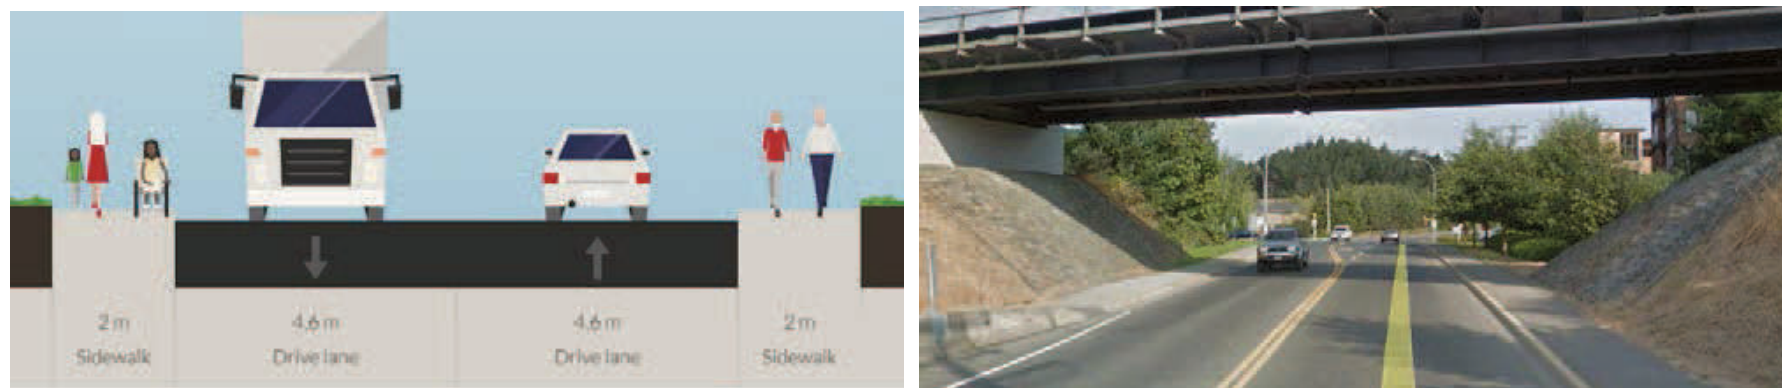
Existing Cross Section

- Current cross section with vehicle and bicycle shared lanes present safety concerns.
- Six Mile Road under Rail Bridge narrows approximately to a 13.2 meter cross section.

- Reduce travel lane width to create additional sidewalk/ cycling amenity.
- Prioritize barrier separating vehicles from sidewalk.
- Prioritize Six Mile Road's east edge, due to higher active mode volumes.
- Coordinate cross section alterations with potential alterations at Atkins Road & Six Mile Road intersection.

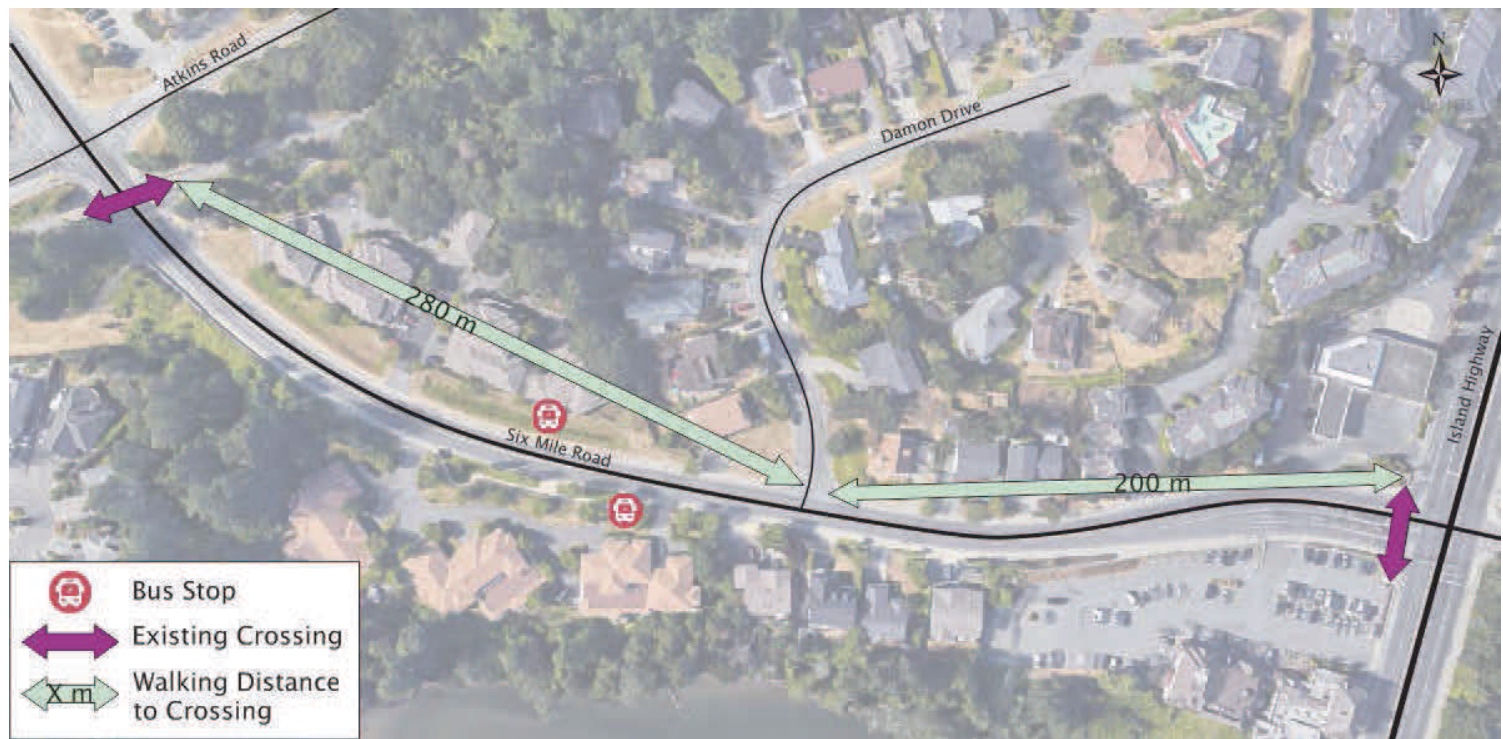
SEGMENT 6: MINOR ROAD RESIDENTIAL ACCESSSES ONTO SIX MILE ROAD

- Delays for vehicles turning from minor roads onto Six Mile Road during weekday AM peak period.
- No pedestrian crossings across Six Mile Road in this segment. Controlled pedestrian crossings at Galloping Goose and Island Highway are approximately 480 m apart. This equates to an approximate 5 minute walk. NACTO suggests that rerouting over 3 minutes is problematic as it often leads to jaywalking.

Vehicles from exiting minor roads do not warrant traffic signal installation due to low vehicle volumes.

The two-lane profile of Six Mile Road with existing traffic volumes provides approximately 62 crossing opportunities per hour based on the future forecasted 2032 traffic volumes. This suggests if the mid-block demand was greater than 15 people per hour a Signed and Marked Crosswalk would be warranted.

Low bus stop service demand. Crossing demand is anticipated to be less than 15 pedestrians per hour.

No recommended changes. Approximate 480 m walking distance and low anticipated crossing demand.

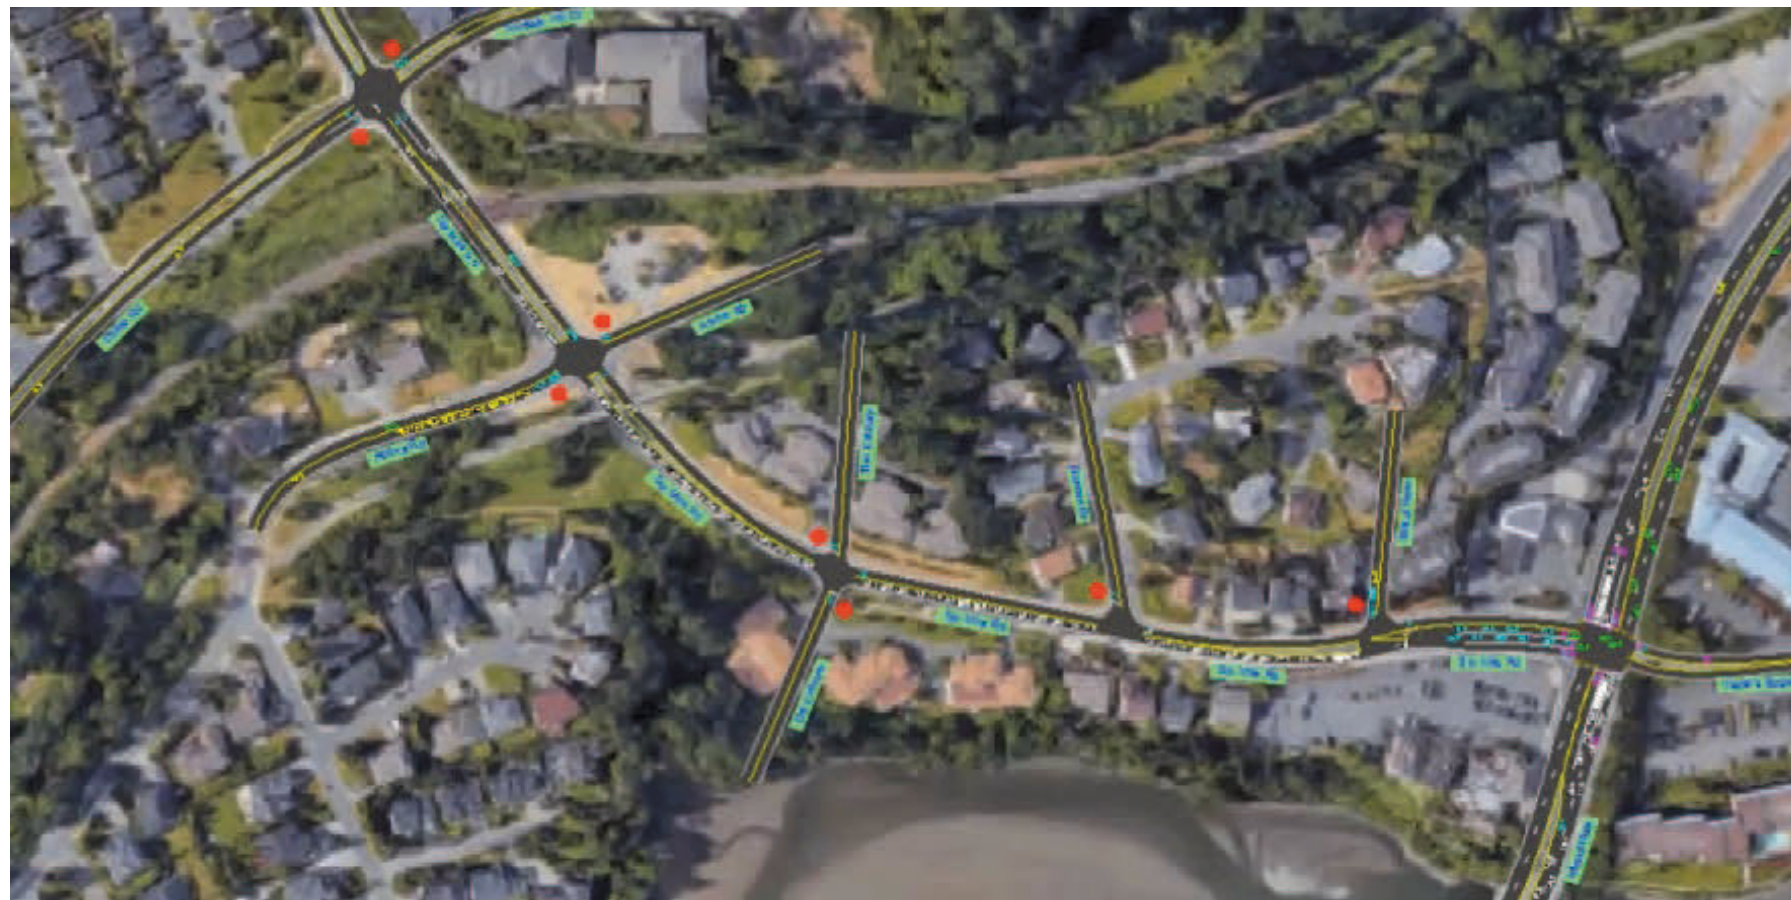
Screen Capture of AM SimTraffic Model Queues

The Island Highway & Six Mile Road intersection demonstrates significant north leg (Six Mile Road approach) delays and corresponding queues in the weekday AM peak period. This left turn movement already has dual left turn lanes. Due to property lines and in consideration of the existing dual left turn lanes, this intersection is considered to be built out in terms of lanes and geometric alternatives.

- Traffic signal optimization is considered the most practical mitigation measure. Analysis suggests extending the southbound left turn phase by six seconds in the weekday AM period. Correspondingly the westbound and eastbound phases should be reduced by three seconds and the northbound movement (from Water's Edge) should be reduced by three seconds. 6-10 more vehicles anticipated to travel through each signal cycle or approximately 160 to 260 vehicles per peak hour. Also extends pedestrian walk phase.
- Our analysis suggests the traffic signal can also be improved during the PM peak hour period by extending westbound phase by five seconds. Correspondingly, the southbound phase should be reduced by five seconds.
- This is a low cost item compared to impact and can be implemented in short term.
